ARH Knit Composite Ltd. (11386)

21.APRIL.2014

ACCORD
on Fire and Building Safety in Bangladesh

Identified Priority 1 Concerns

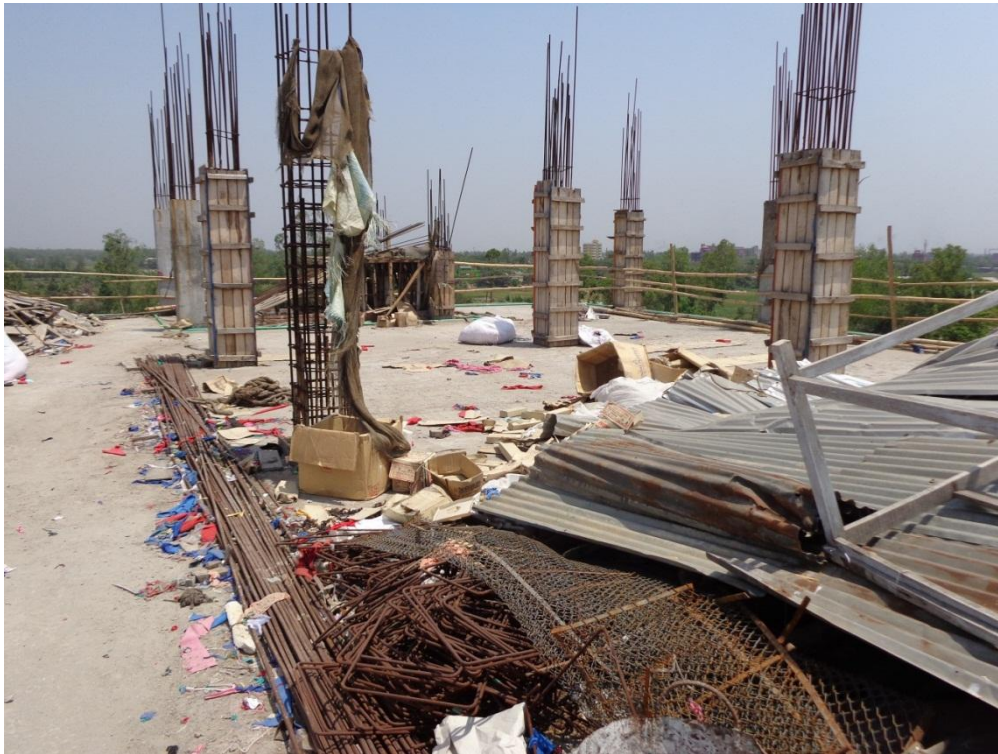
Photo taken at the 4th floor level
(roof)

**Intent to continue construction beyond the
5th Storey**

The owner intends to continue construction up to the 10th storey.
Column load run-downs indicate very high column stresses for a 10 Storey Construction:

ITEM 1: (Priority 1) As discussed at the factory, the owner wants to build a full 10 storeys, but is so far at the 4th floor level. A full Detailed Engineering Assessment and full verification must be carried out for the entire project, before any further construction.

Continuation of the construction beyond the 5th storey above ground, possibly up to the 10th storey.

- **To build to 7th storey + roof:** A Structural Engineer must assess the structure in conjunction with the lack of reinforcing steel in the columns and the column stresses developed over the height of 7 storeys (plus basement).
- **To build to 9th storey + roof:** A Detailed Engineering Assessment is required to validate the suitability of the materials and construction to support the additional levels.

For both cases; implement any corrective works prescribed by the Detailed Engineering Assessment.

- For any construction above the 6th storey, but below 9th storey, a Structural Engineer is to conduct an assessment of the design loads and column stresses.
- The feasibility of construction above the 8th storey is to be evaluated by a Detailed Engineering Assessment.

- Begin implementation of any corrective works deemed necessary by the DEA or assessment.

- Fully implement any corrective works deemed necessary by the DEA or assessment.

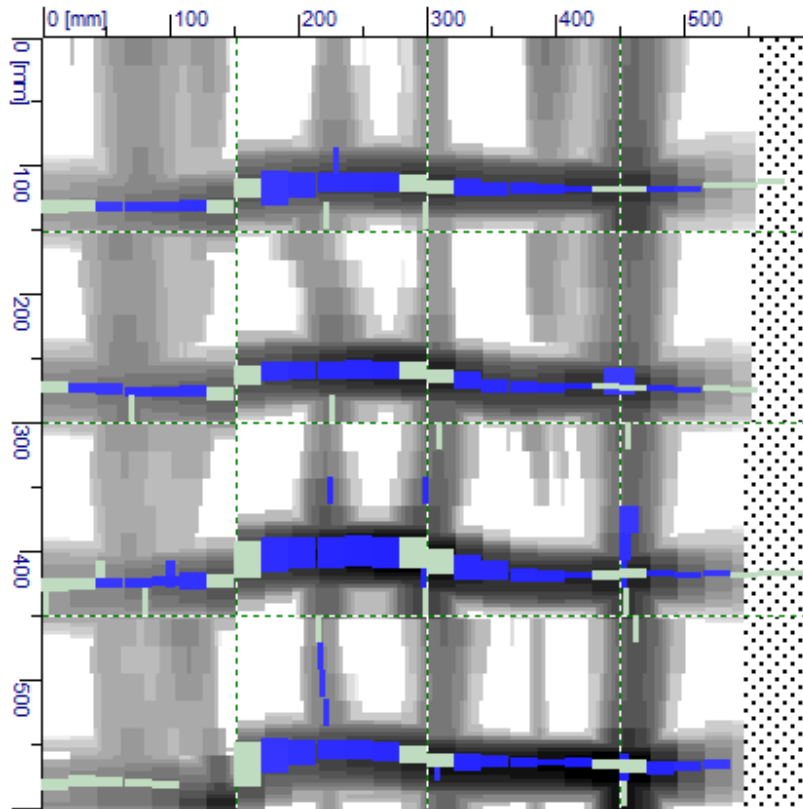
As measured at the factory with the Ferro-scanner, instead of 20x20mm bars, we found 16x20mm bars. This situation has direct consequence for the continuation of the project up to the 10th Storey + Basement.

Reinforcing steel is missing

ITEM 2: (Priority 2) As measured at the factory with the Ferro-scanner, the column reinforcing found in places is not as per the Structural Drawings.

Deficient Rebar quantities in the columns.

- Begin a confirmation survey of column reinforcement for use in the Structural Engineer's assessment or the Detailed Engineering Assessment.

- Begin any corrective works deemed necessary by the DEA.

- Complete any corrective works deemed necessary by the DEA.

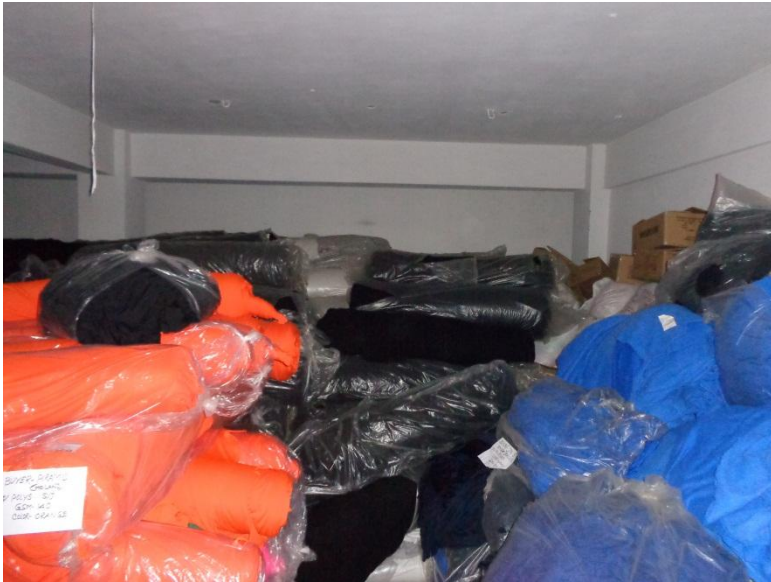
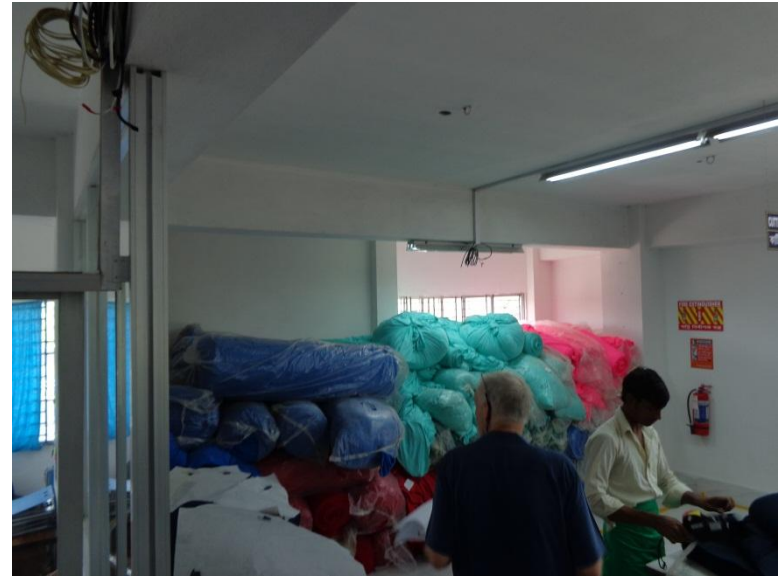
No loading plan is in place for any of the floors to ensure compliance with actual design loads. A loading plan is required to be developed for every floor.

No Loading Plans in place

ITEM 3: (Priority 3) There were no loading plans in effect and some moderately heavy storage was observed within the factory.

High levels of storage in certain areas and no Loading Plans in place.

- Confirm allowable design floor loadings.

- Factory Engineer to produce and actively manage a loading plan for all floor plates within the factory giving consideration to slab, beam and column capacities.

- Maintain and enforce the Loading Plans.
