Apparels Express Ltd. (11637)

Baranda, Kashimpur, 1346, Gazipur.

01.07.2014

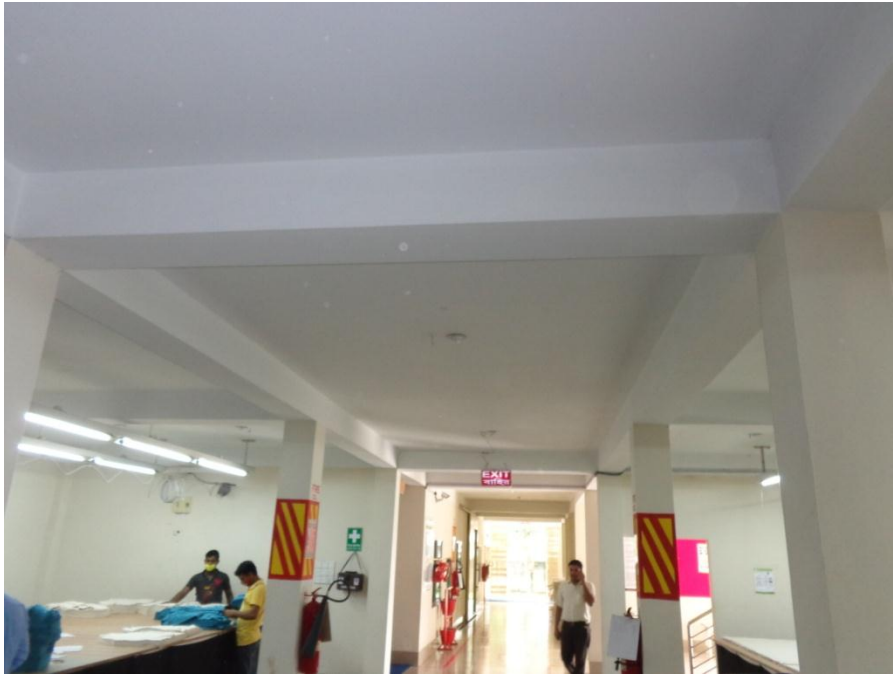
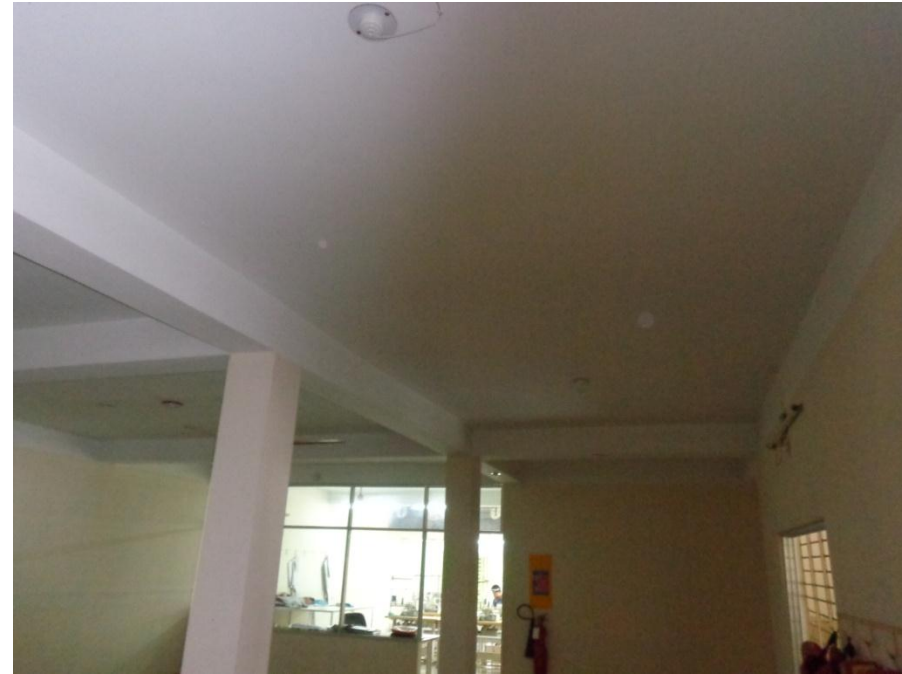
1st Priority 2 Concern

Beams were missing in the Ground Floor & 1st Floor

Some beams were missing in the Ground Floor & 1st floor of the main factory.

Item No.	Observation	Recommended Action Plan	Recommended Timeline
1	1st Priority 2 - Beams were missing in the Ground Floor & 1st floor.	Carry out an Engineering Assessment to verify slabs capacity.	6-weeks
2	1st Priority 2 - Beams were missing in the Ground Floor & 1st floor.	Carry out any recommendations from the Engineering Assessment. Update structural drawing.	6-months
3	1st Priority 3 - Poorly design steel roof of the staircase (Main Building) and Security Room	Factory Engineer to review the steel roof structure and connections against uplift loads as per BNBC.	6-weeks
4	1st Priority 3 - Poorly design steel roof of the staircase (Main Building) and Security Room	Implement any strengthening recommended by Factory Engineer. Produce as-built drawing for auxiliary buildings.	6-months
5	The buildings does not have any obvious lateral stability system.	Carry out engineering assessment on the building to verify that it is stable under lateral loading as per BNBC.	6-weeks

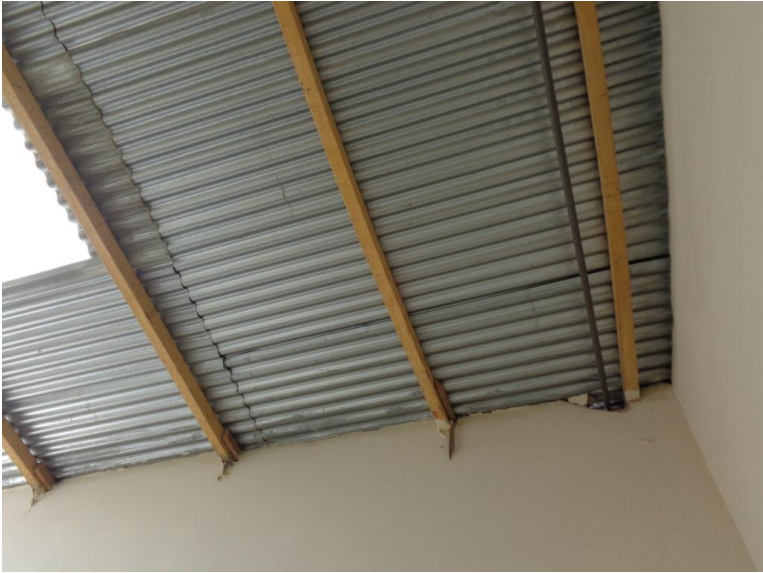
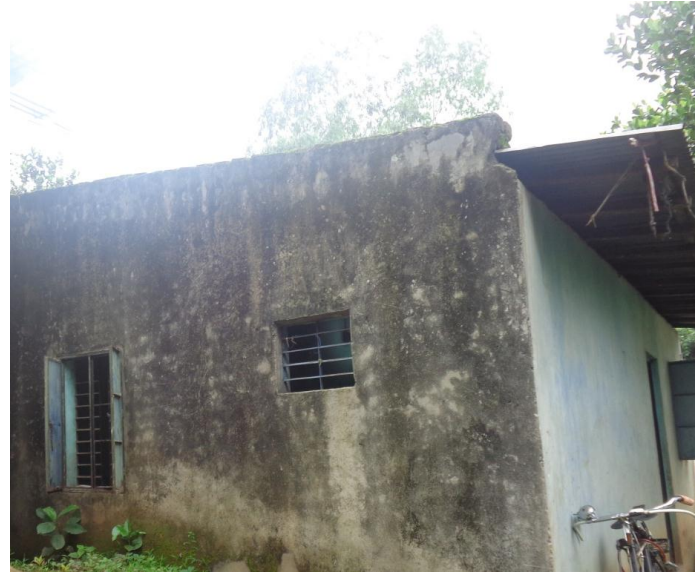
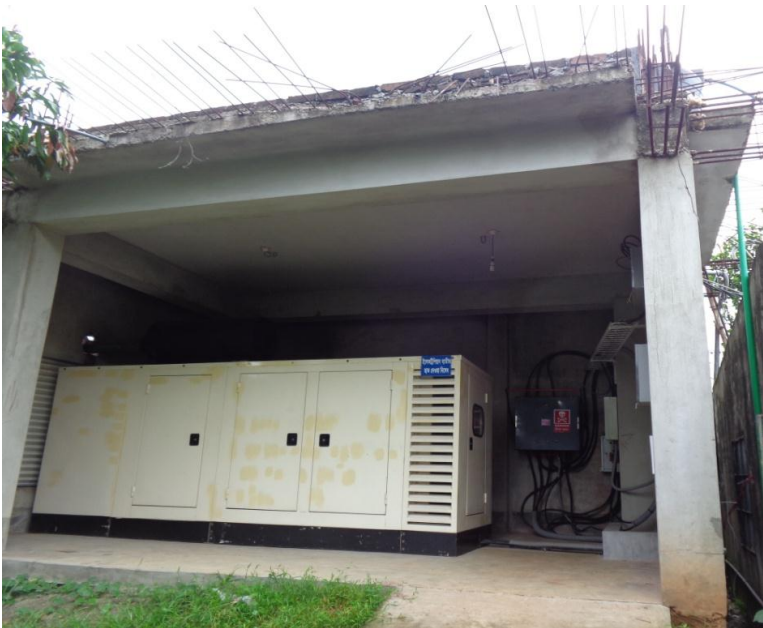
1st Priority 3 Concern

Poorly design steel roof of the staircase (Main Building)
and Security Room

Poorly design steel roof of the staircase and Security Room

No documentations were provided regarding these structures.

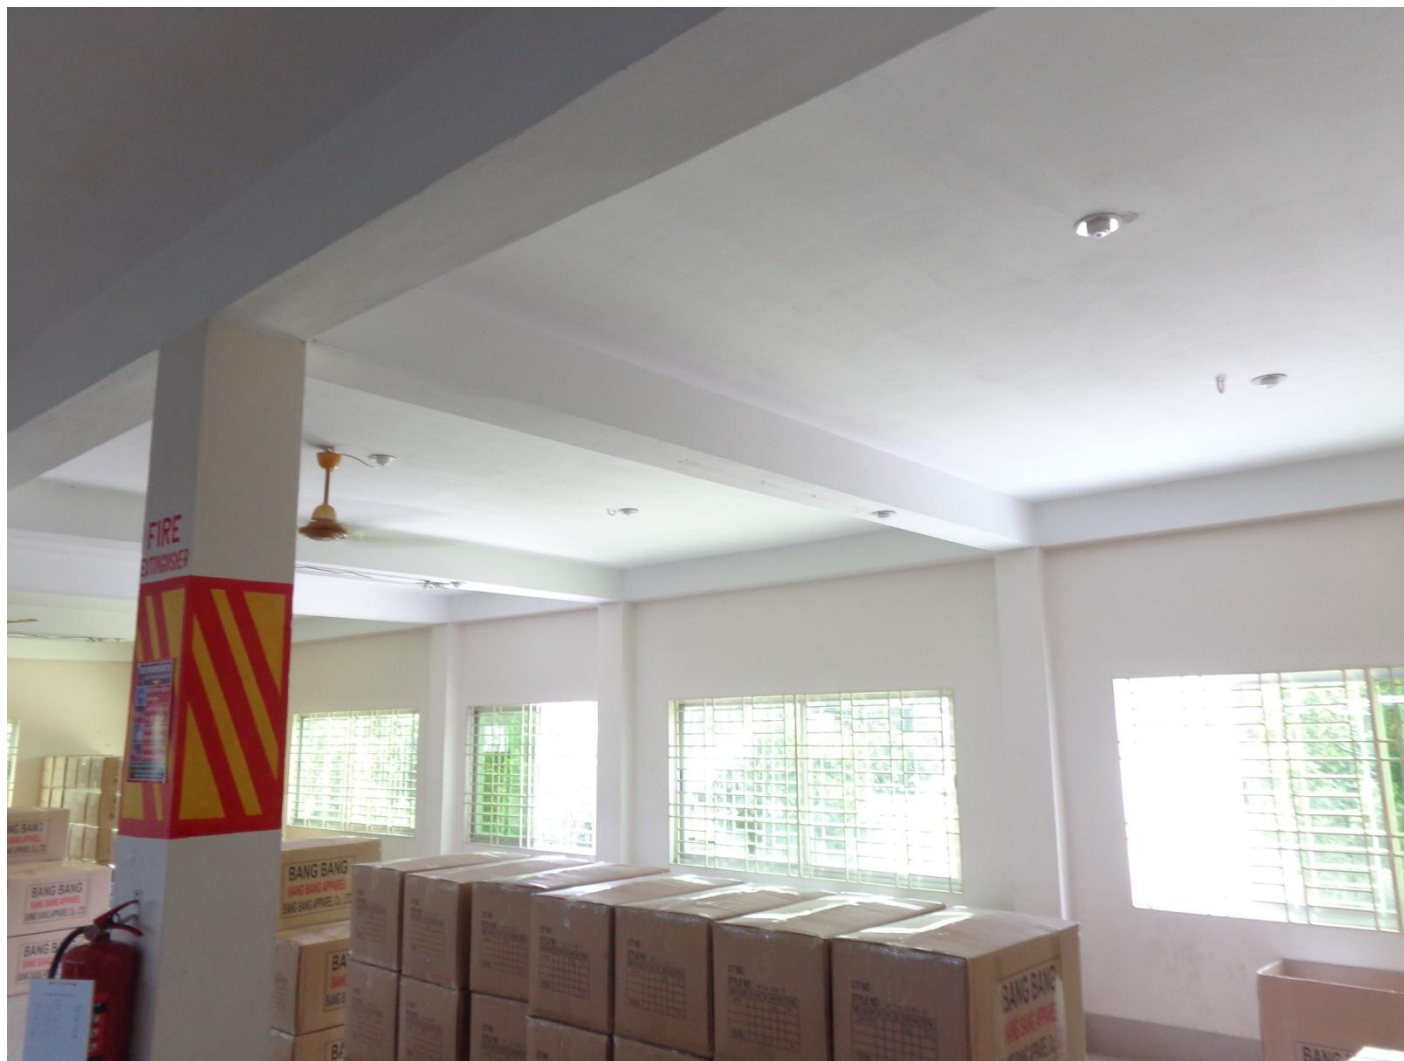
Overall Stability System

The building did not feature any core or shear walls. Stability was achieved through sway action between beams and columns and masonry infill walls.

We require that these items be investigated in a Detail Engineering Assessment

6	The buildings does not have any obvious lateral stability system.	Carry out recommendations of engineering assessment.	6-months

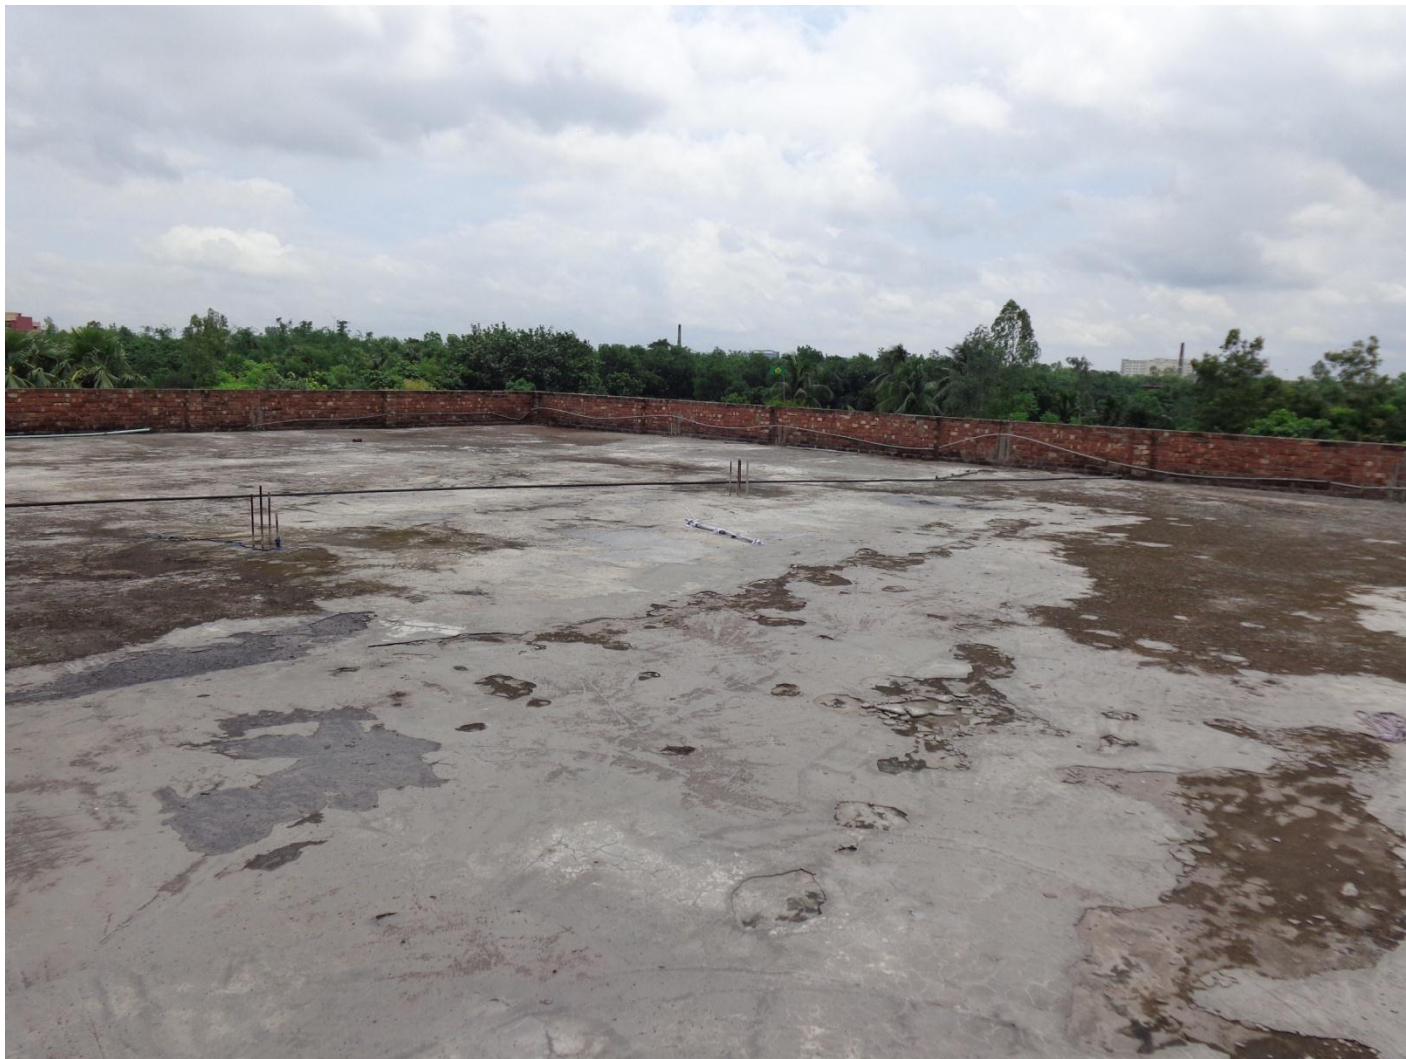
Water Ingress at Roof Level

No waterproofing membrane was visible on the roof of the building. This means that any cracks in the surface finishes on the roof will allow water to seep into the concrete slab beneath the finishes, and cause corrosion of the reinforcing steel.
