# Arjon Fashions Ltd. (9972)

Yearpur, Zirabo, Ashulia, Dhaka.

05.AUGUST.2014

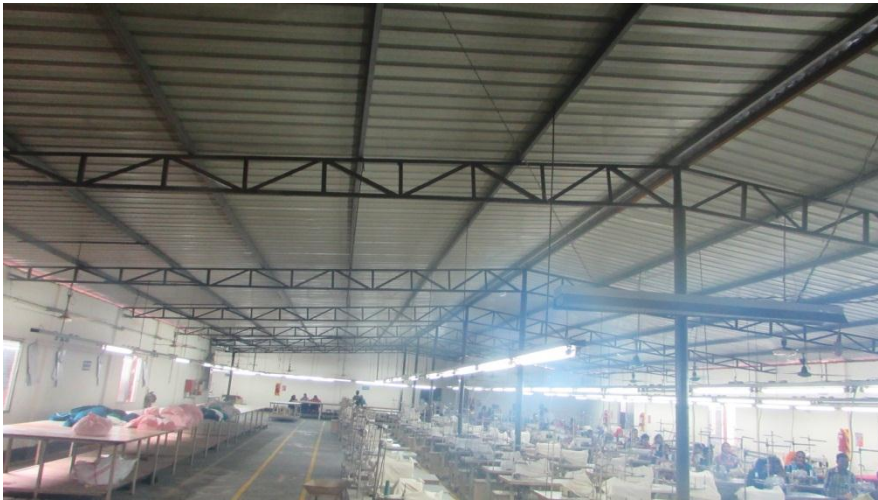
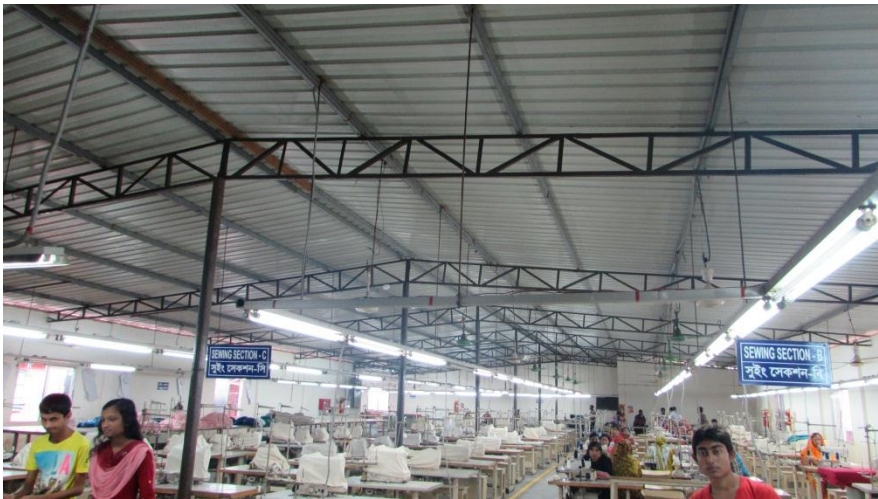
## 1<sup>st</sup> Priority 3 Concern

The steel trusses need to have a longitudinal roof bracing system to provide the stability and to resist wind loading.

The factory's Structural Engineer needs to review the design to check the stability of the trusses under lateral wind load.

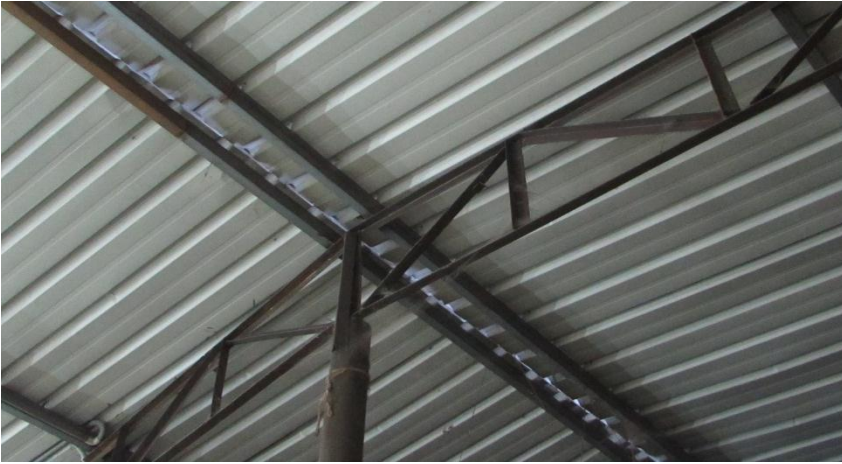
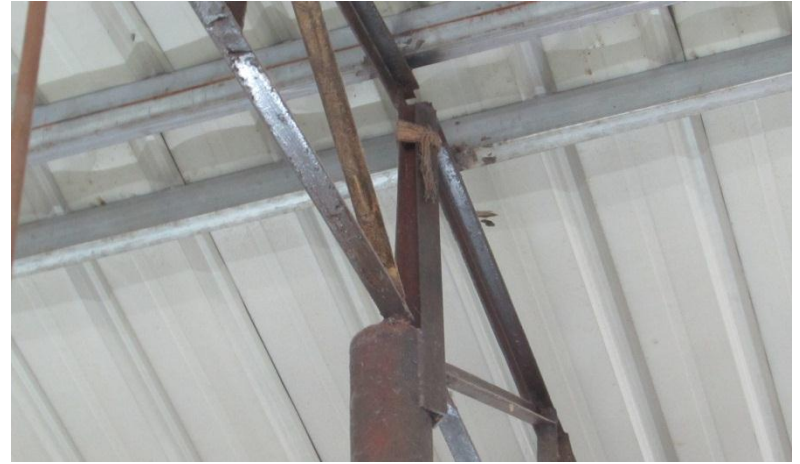
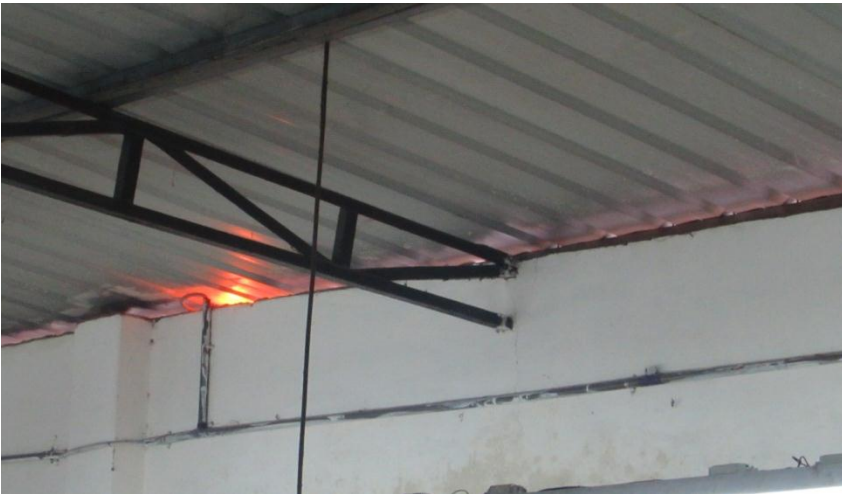
## 2<sup>nd</sup> Priority 3 Concern

The steel connections need to be reviewed and revised if necessary, depending on the proper designed details.

The factory's Structural Engineer needs to review the design and in particular the uplift forces on the trusses under wind uplift loads to determine if the current connections are adequate.

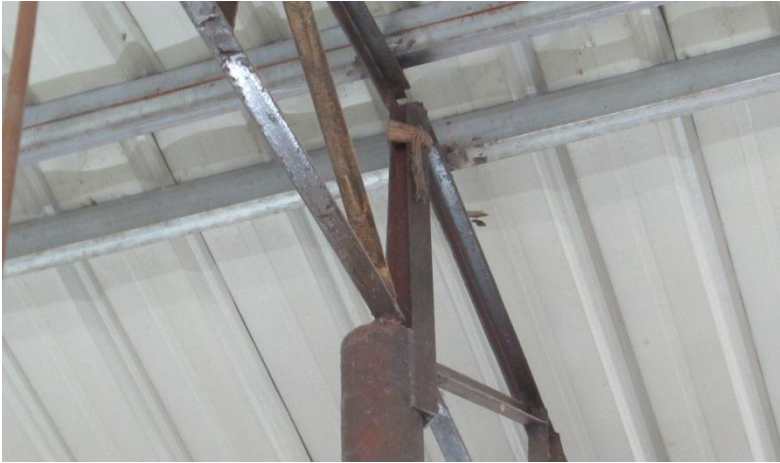
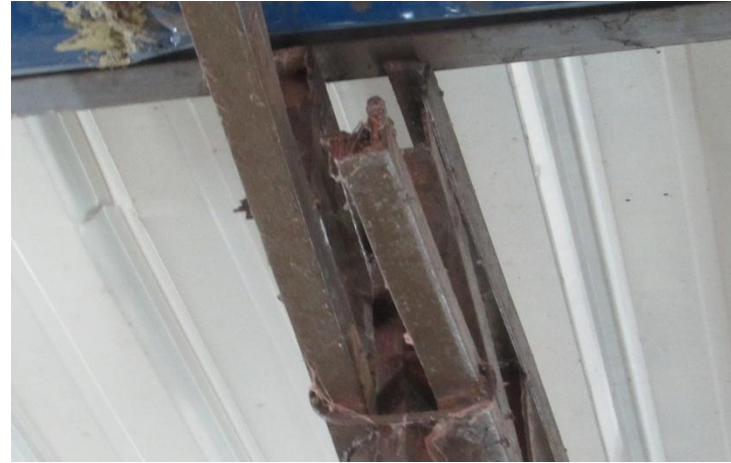
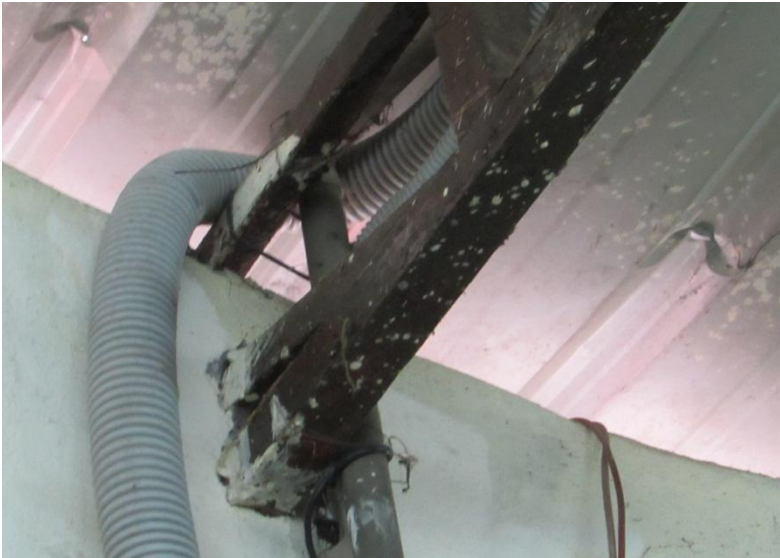
### 3<sup>rd</sup> Priority 3 Concern

The steel trusses have not been painted and are already corroding.

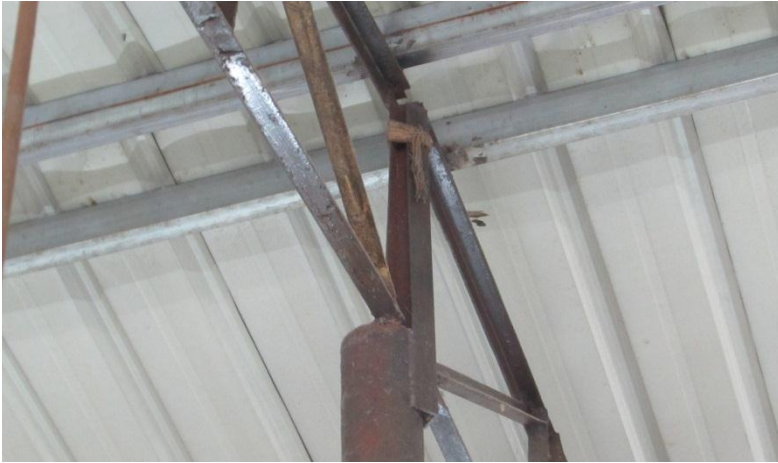
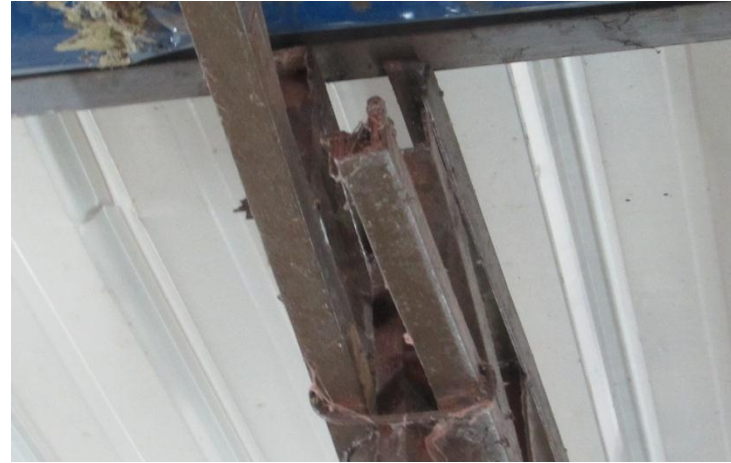
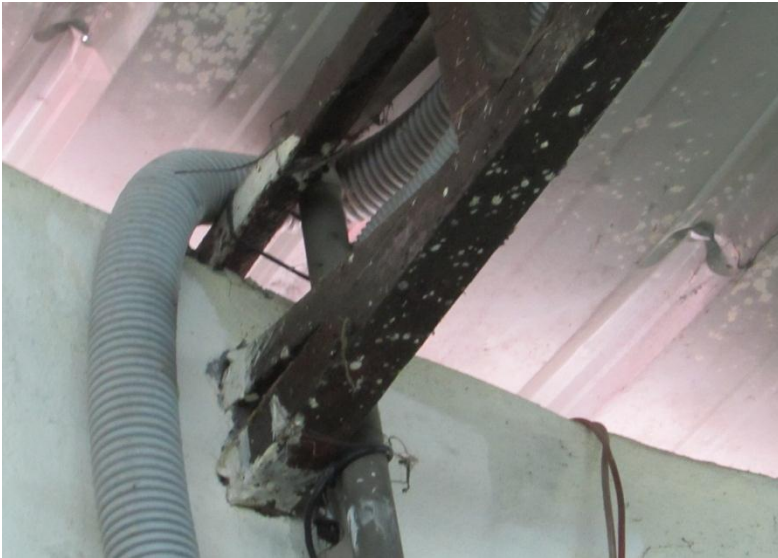
## 4<sup>th</sup> Priority 3 Concern

The steel structure have not been applied the fire proofing yet.

The fire proofing needs to be applied with minimum 1-2 hours in compliance with BNBC.

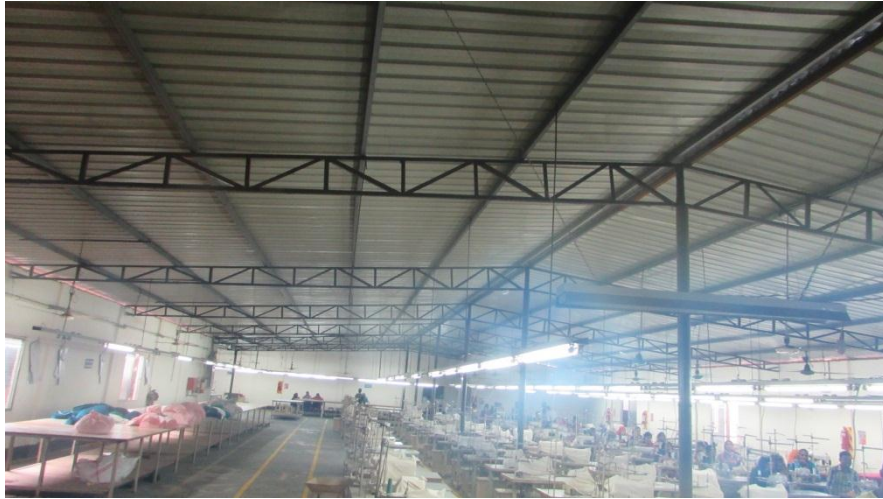
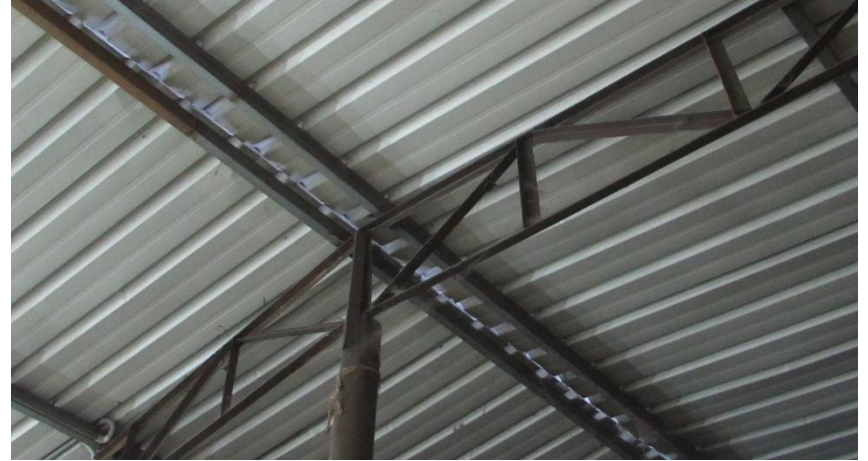
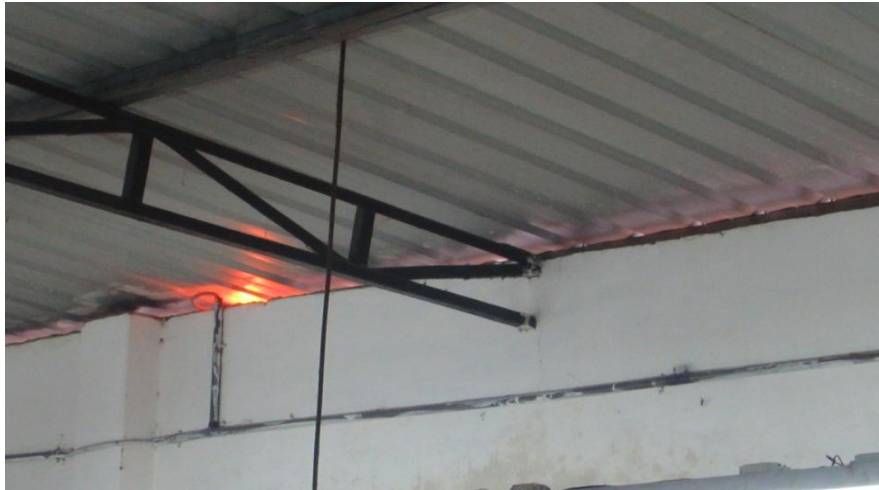
## 5<sup>th</sup> Priority 3 Concern

There are no structural design drawings for any of the steel structural members steel connections.

The factory's Engineer should survey the actual conditions and produce the drawings as early as possible.

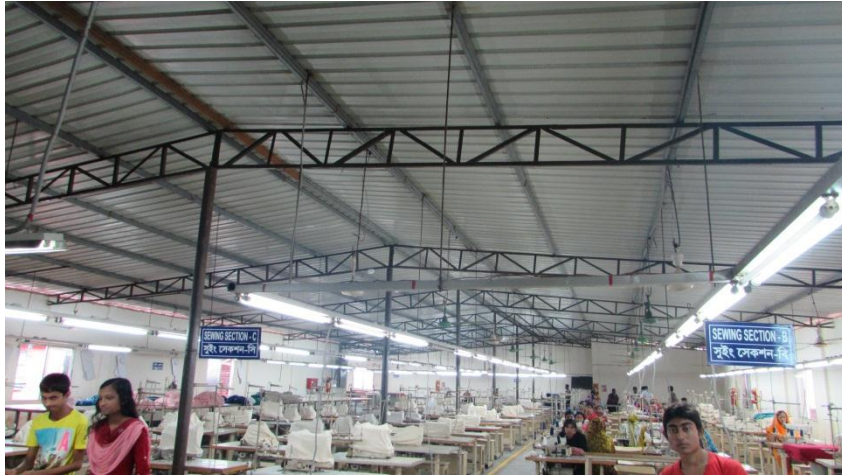
# Overall Stability System

The brick columns and brick walls are the main elements currently available to resist lateral wind loads.

For a single storey building with a large plan area, this type of structure may be appropriate. However, it is required that an Engineer reviews and checks the stability of the brick walls and columns under these conditions.

The steel trusses need to have longitudinal bracing to combine the trusses as one system.

The factory's Structural Engineer needs to review the design to check the stability of the trusses under lateral wind loads.
