ELECTRICAL SAFETY INSPECTION REPORT

BIG BOSS CORPORATION LTD., MIDDLE BADDA, GULSHAN,
DHAKA-1212, BANGLADESH

Inspected on November 09, 2013

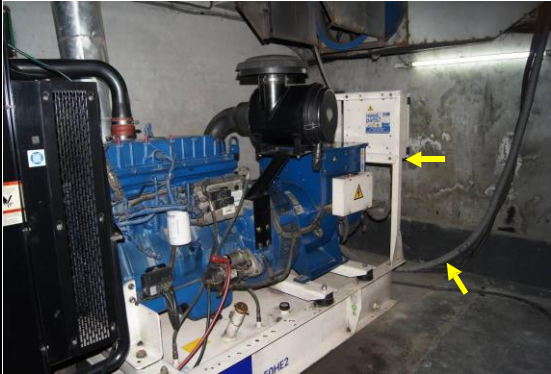
Finding #: E- 1

Category: GENERATOR ROOM	
Finding: Cable termination at the generator control panel is laid on the floor covered in flexible PVC conduit and not fixed with cable lugs.	
Recommendation: Cable must be laid and supported on cable trays and raisers and must be fixed firmly with cable glands through gland plate	
Remediation Timeframe: 3 Months	Wiring and cable installation inside generator room

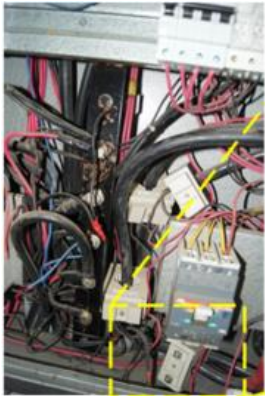
Finding #: E- 2

Category: TRANSFORMER ROOM	
Finding: Cables and wires inside panels are not dressed.	
Recommendation: Cables terminating to & from panel must be dressed to avoid short circuit in side panel and to ease maintenance.	
Remediation Timeframe: 3 Months	Wiring inside LT panel

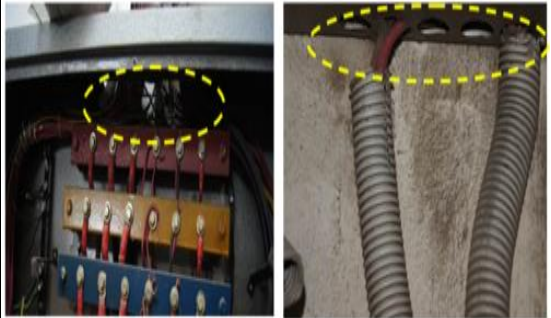
Finding #: E- 3

Category: TRANSFORMER ROOM	
Finding: Cables/wires entering/leaving panels are not firmly fixed...	
Recommendation: Cables terminated to panel must be firmly fixed with cable glands through gland plate.	
Remediation Timeframe: 3 Months	Cables and wirings terminating at distribution panel (typical)

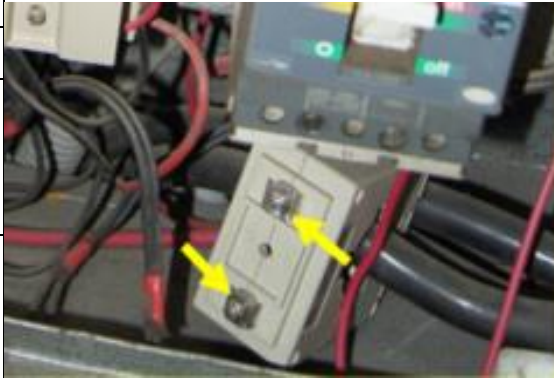
Finding #: E- 4

Category: TRANSFORMER ROOM	
Finding: One of the current transformers secondary in second floor panel is left open (not connected).	
Recommendation: It is dangerous to keep the secondary of CT open. It must either be removed or else shorted to avoid high terminal voltage.	
Remediation Timeframe: 3 Months	Current transformer installed inside LT panel without secondary side not connected.

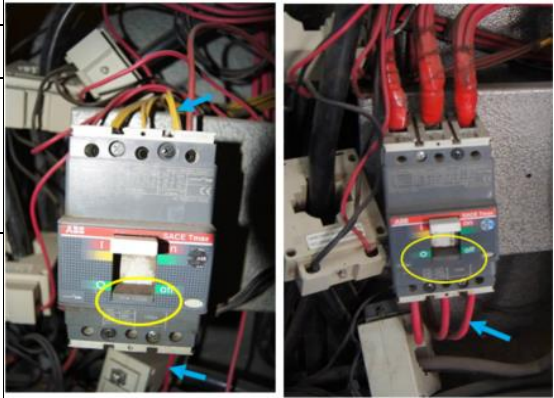
Finding #: E- 5

Category: BOILER & COMPRESSORS	
Finding: Cables used do not correspond to the size of the MCCB connected.	
Recommendation: The capacity of the MCCB (100A) installed is too large for the incoming line size used. Selection of cable size and MCCB must be designed as per the requirement.	
Remediation Timeframe: Within 1 Month	Smaller size cables connected to higher rated MCCBs (Typical)

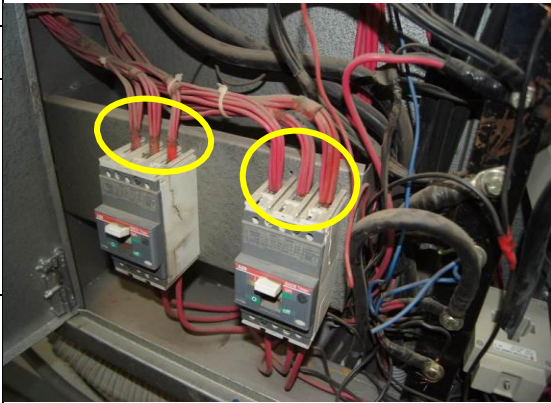
Finding #: E- 6

Category: TRANSFORMER ROOM	
Finding: Multiple wires (bunched) are terminated at a terminal in MCCBs.	
Recommendation: Not more than 2 cables must be terminated at one point. A large size cable can be used to connect from the output of the MCCB to Bus bar from where individual MCBs may be supplied. It can also be done by using MCB terminal shorting loop of proper size.	
Remediation Timeframe: Within 1 Month	Multiple wires terminating at MCCB terminals

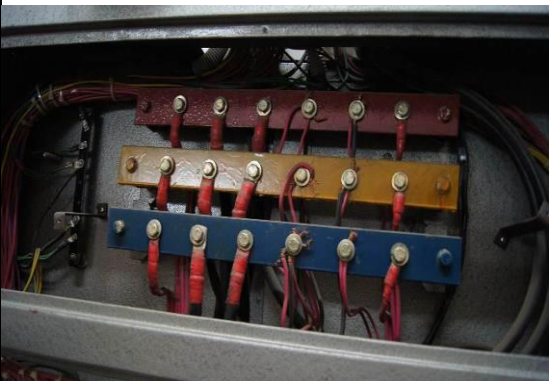
Finding #: E- 7

Category: TRANSFORMER ROOM	
Finding: Bus bars are painted with enamel paints to identify phase.	
Recommendation: For proper electrical connection / bonding, the paints must be removed at the terminal points. Paints within joints may increase contact resistance and may cause heating. The paint is combustible and is not recommended for high current. It may be replaced by heat shrink insulating rubber boots.	
Remediation Timeframe: 3 Months	Bus bars inside distribution panel painted with enamel paints (Typical)

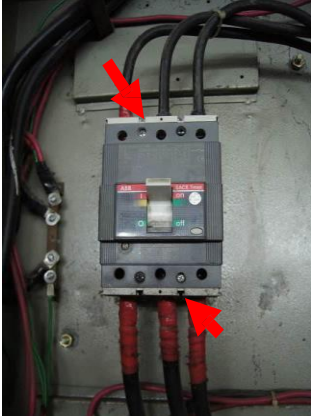
Finding #: E- 8

Category: TRANSFORMER ROOM	
Finding: Barriers between different phases are not installed on MCCB.	
Recommendation: Phase separation between MCCB terminals must be installed to avoid short accidental short circuit.	
Remediation Timeframe: Within 1 Month	Cables terminating at MCCB terminals inside panel without phase barriers (typical)

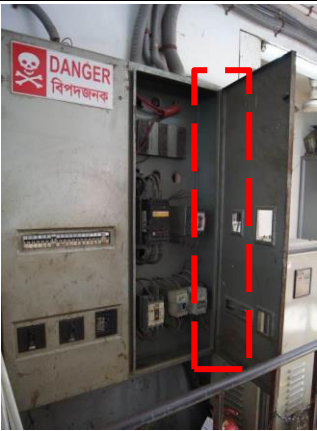
Finding #: E- 9

Category: GENERATOR ROOM	
Finding: Panels are not connected with separate earth and no earth bonds are provided between panel board and swing door(s).	
Recommendation: Panels must be connected with separate earth and every metal swing doors must be connected with earth bond.	
Remediation Timeframe: Within 1 Month	Panel doors not bonded (typical)

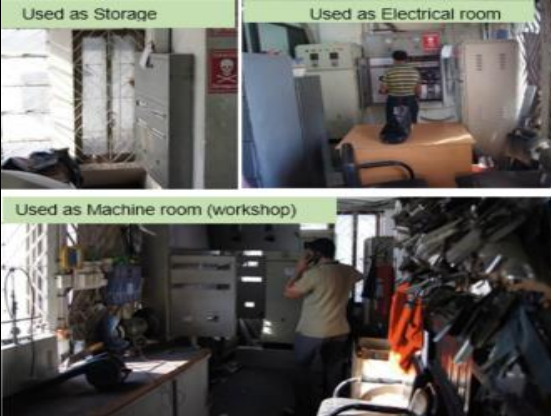
Finding #: E- 10

Category: GENERATOR ROOM	
Finding: LT panel board rooms on third floor and seventh floor are used for other use, which has congested the surroundings.	
Recommendation: a) The electrical room in third floor must be moved to another place and all furniture including grinding machines must be removed. b) Machine room on seventh floor LT panel room must be moved to other places and the space surrounding the panels must remain clear. c) Storage surrounding the other panel on third floor must be cleared and kept free all times	
Remediation Timeframe: Within 1 Month	Storage near panels and tables arranged in front of panels (typical)

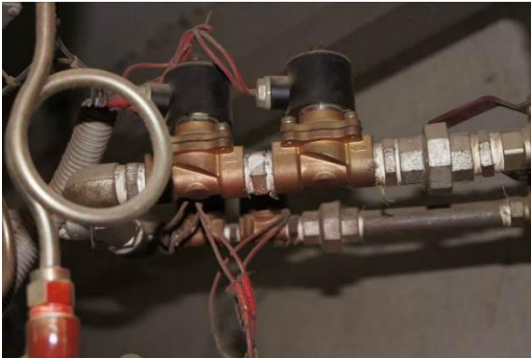
Finding #: E- 11

Category: SWITCHBOARDS AND PANELS	
Finding: Cables run in boiler rooms are not protected from ambient heat.	
Recommendation: Cables and wires used in boiler room must be covered/protected from ambient heat from the boiler.	
Remediation Timeframe: 3 Months	Wirings exposed in boiler room

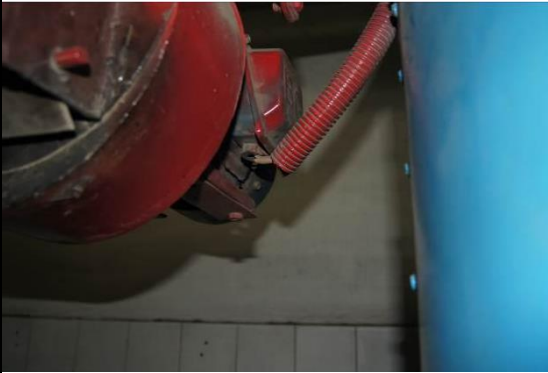
Finding #: E- 12

Category: SWITCHBOARDS AND PANELS	
Finding: Cables/wires terminating at Motors/panels and devices are not fixed firmly.	
Recommendation: Cables terminating at motors, panels and devices must be terminated with proper cable gland. Cables/conduits must be supported on cable trays or raisers.	
Remediation Timeframe: 3 Months	Cables terminating at motor inside boiler room.

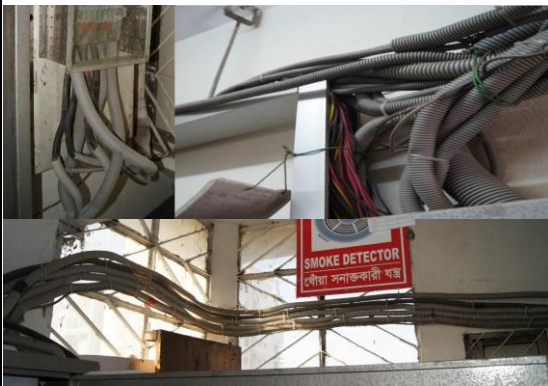
Finding #: E- 13

Category: SWITCHBOARDS AND PANELS	
Finding: Cables and wires are run in flexible PVC conduits (not continuous) supported with cable ties and metal strips on walls, ceiling and floors.	
Recommendation: Cables must be run in rigid conduits of proper sizes and must be continuous throughout length. Bends, corners and tees must be used to navigate corners. Cable trays with proper accessories may be used to support cables	
Remediation Timeframe: 6 Months	Cables and wirings inside factory building. Section of the wirings supported on window grill (typical)

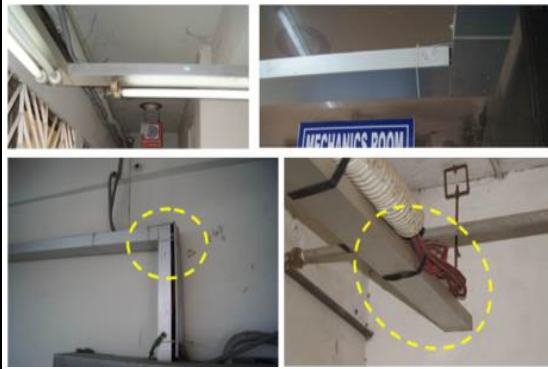
Finding #: E- 14

Category: SWITCHBOARDS AND PANELS	
Finding: Aluminum tray/channels used to support cables or run wirings, in third & seventh floors, are mostly supported from the ceiling but are not installed with proper bends, joints and cover.	
Recommendation: Aluminum channels used for cable trays or the wiring ducts must be used with proper corners, bends and covers.	
Remediation Timeframe: 3 Months	Wiring ducts supporting wiring above work tables inside production floors installed without accessories (typical)

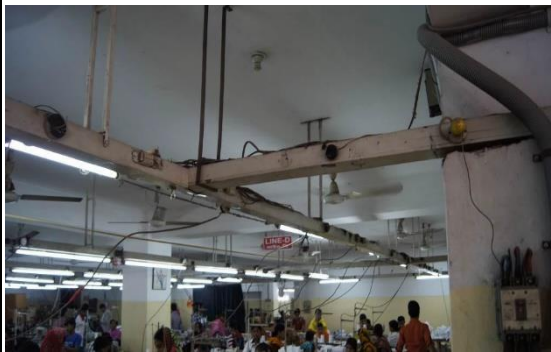
Finding #: E- 15

Category: SWITCHBOARDS AND PANELS	
Finding: The wooden ducts are used in second floor to run wirings, and often support cables/flexible PVC conduits, does not have cover & bends.	
Recommendation: The wooden ducts used must have removable covers to prevent from dust and damages. Only wires and cables of smaller cross-sectional area may be used as it does not provide bends & elbows.	
Remediation Timeframe: Within 1 Month	Wooden ducts installed overhead supporting wiring in section of production floor wiring.

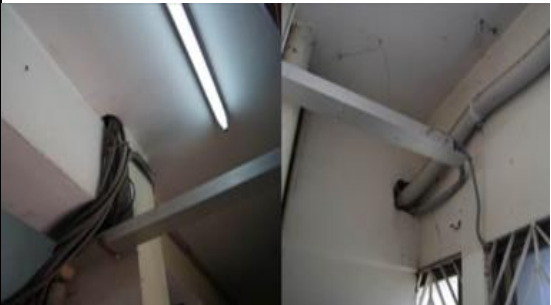
Finding #: E- 16

Category: SWITCHBOARDS AND PANELS	
Finding: Cables & wires passing through walls, floors and ceilings are not protected from mechanical damages.	
Recommendation: Cables passing through walls, ceiling or floors must be protected from mechanical damages by running through rigid ducts (steel conduits, steel ducts).	
Remediation Timeframe: 3 Months	Cables inflexible PVC conduits passing through walls unprotected (typical)

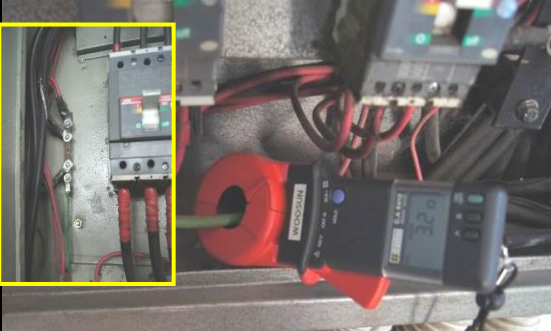
Finding #: E- 17

Category: SWITCHBOARDS AND PANELS	
Finding: Earth conductors used to loop panels, devices and equipment is not continuous. The earth loop resistance measured at different points range from 3 - 5 ohms (main conductors) and 18 – 90 ohm in branches. High leakage current (9A - 11A) is measured through SDB main conductors.	
Recommendation: a) Mid span joints to provide earth for devices/panels must be avoided. b) Multiple earth conductor termination through a cable lug/ferrule must be avoided. c) Earth conductor must be continuously looped from main earth (electrode) to the end connection.	
Remediation Timeframe: Within 1 Month	Measuring high earth loop impedance (main). Multiple earth conductors terminating at a terminal on earth strip inside panel (inset)
