# INITIAL STRUCTURAL INTEGRITY ASSESSMENT REPORT (SIAR)

Factory Name: **Fashion Store Ltd.**

Assessor: **Shaheedullah**

Date: **20 May 2014**

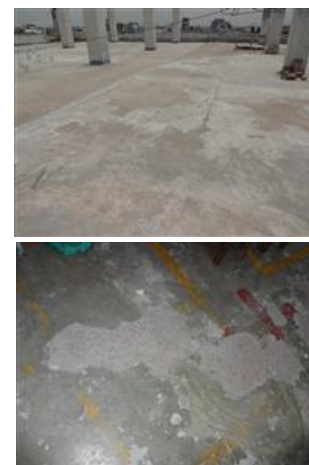
Question:	Have all areas of needed maintenance, including areas with efflorescence, dampness, standing water on rooftops, and corrosion been addressed.
Priority Level:	Medium
Non-Compliance Level:	2
Description:	Sign of standing water at the roof top was noticed. The floor finish at the 5th floor slab between longitudinal grid 5&6 and transverse grid H&I was noted to be damp.
Source of Findings:	Photograph: Attached., Visual Assessment: Visual inspection.
Suggested Plan of Action:	A qualified structural engineer shall be engaged to address all areas of needed maintenance by correcting the identified issues. Roof top shall be protected by providing water proof course with gentle slope for easy drainage

of rain water outside of the building and partially damaged part of slab shall be repaired.	
Suggested Deadline Date:	15 Aug 2014	
Standard:	Alliance Standard Part 8 Section 8.26 Durability and Maintenance
