Gulf Knitting & Textile Ltd

121-122 Sataish Road, Gazipura, Tongi, Gazipur

28th January 2015

Observations

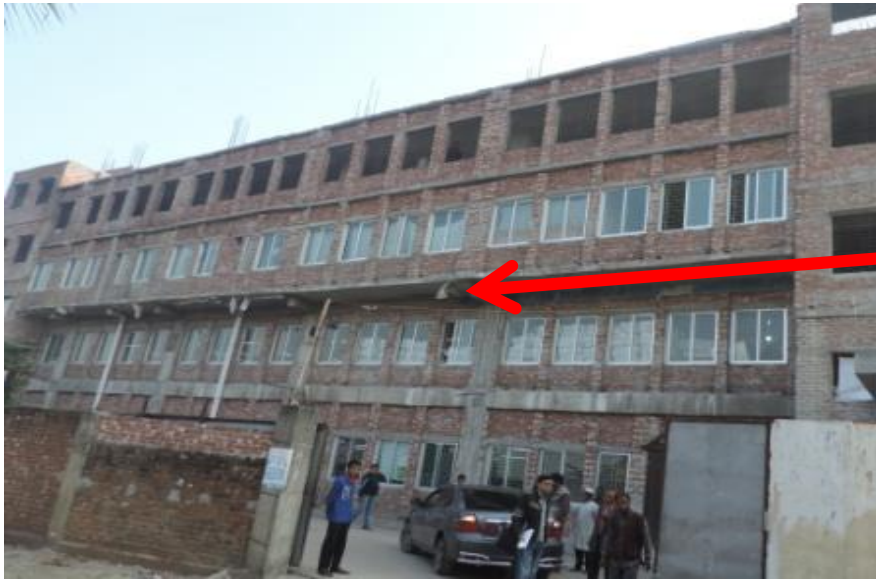
Large cantilever to front elevation at 3rd Level and above. Sagging of slab noted between cantilever beams

ITEM 1: Cantilever slab at front elevation appears to be sagging between beams

Item No.	Observation	Recommended Action Plan	Recommended Timeline
1	Cantilever slab at front elevation appears to be sagging between beams	Building Engineer to review design, loads and slab capacity in this area	6-weeks
2	Cantilever slab at front elevation appears to be sagging between beams	Carry out any remedial action necessary from Building Engineer's review	6-months
3	Lack of management of floor loading	Building Engineer to produce and actively manage a loading plan for all floor plates within the factory, giving consideration to floor capacity particularly cantilevers and column capacity	6-weeks
4	Lack of management of floor loading	Continue to implement load plan	6-months
5	Discrepancies between the structural drawings and the permit drawings. 3rd, 4th and 5th level suspended floor plates have been built with perimeter cantilevers	Building Engineer to survey as-constructed building. Updated drawings to be prepared showing the correct as-constructed layout.	6-weeks

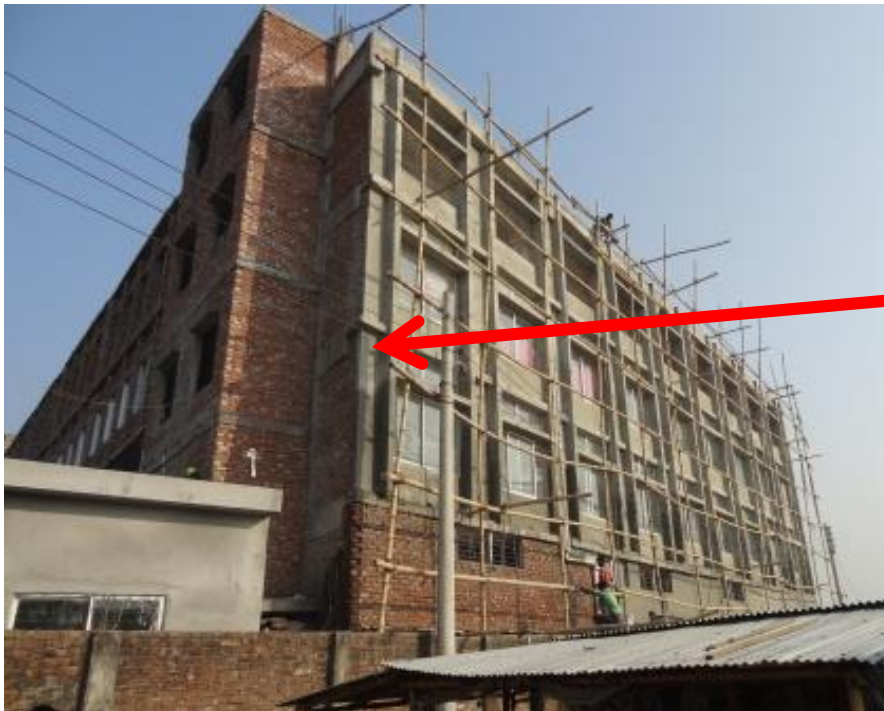
Cantilever at south elevation. Cantilever beam does not go to end. Only slab supports facade for last 300mm of cantilever.

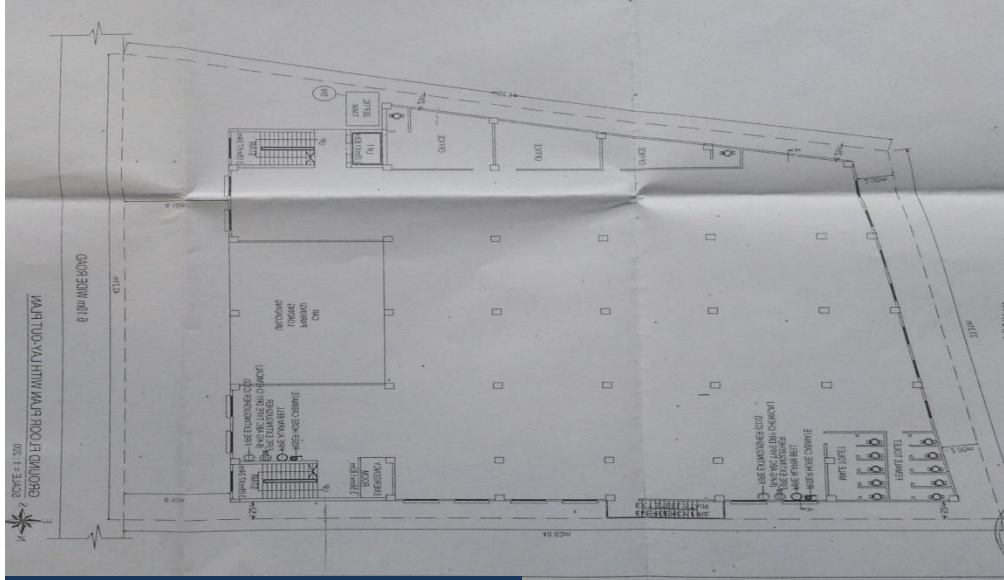
Permit Drawing

Permit Drawings different from Structural drawings:

- No cantilevers shown on permit drawings
- Number of bays different between permit and structural drawings
- Stairs layout and location different in both sets of drawings
- Structural drawings substantially reflect structure as built

ITEM 3: Discrepancies between the structural drawings and the permit drawings. 3rd, 4th and 5th Levels suspended floor plates have been built with perimeter cantilevers

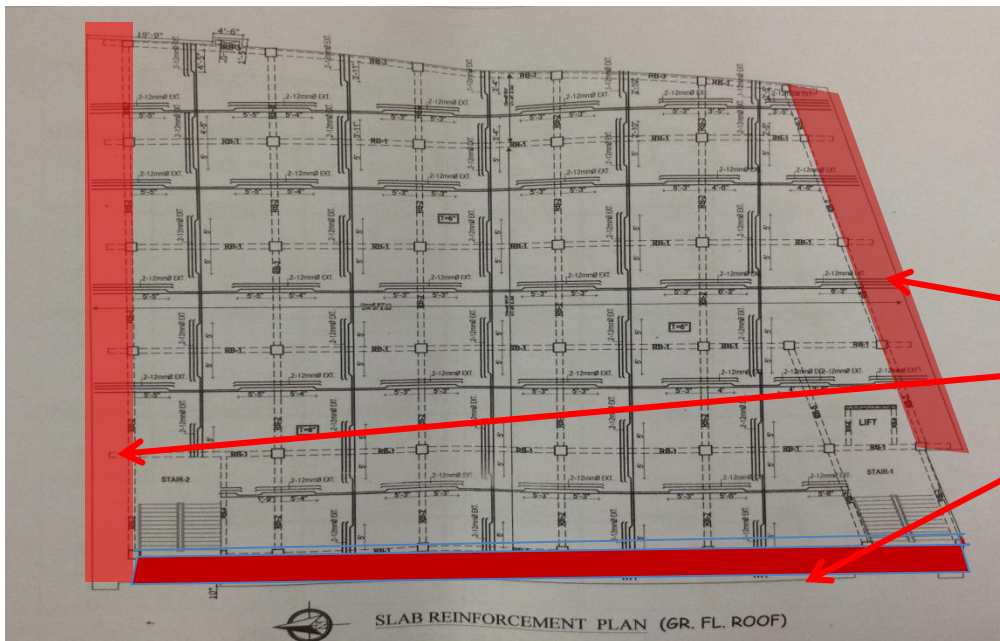
Structural Drawing (Typical Floor Plan)

Cantilever portions not shown in permit drawings for Levels 3 & 4

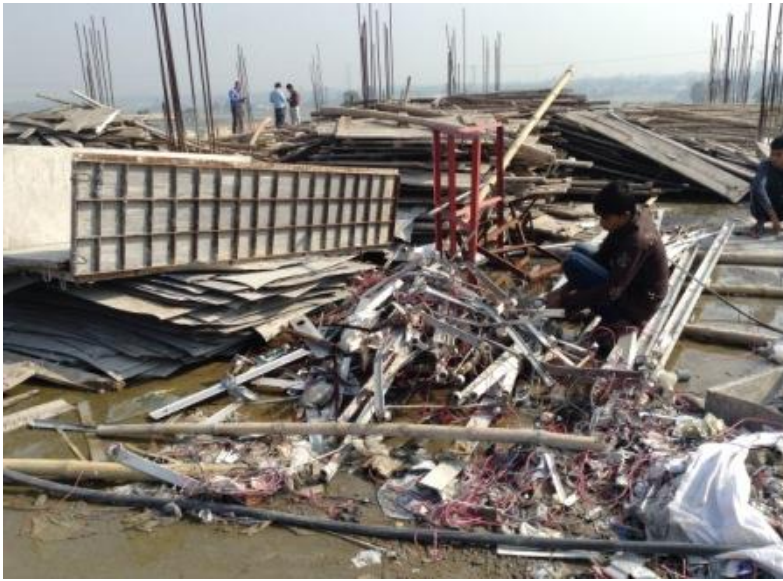
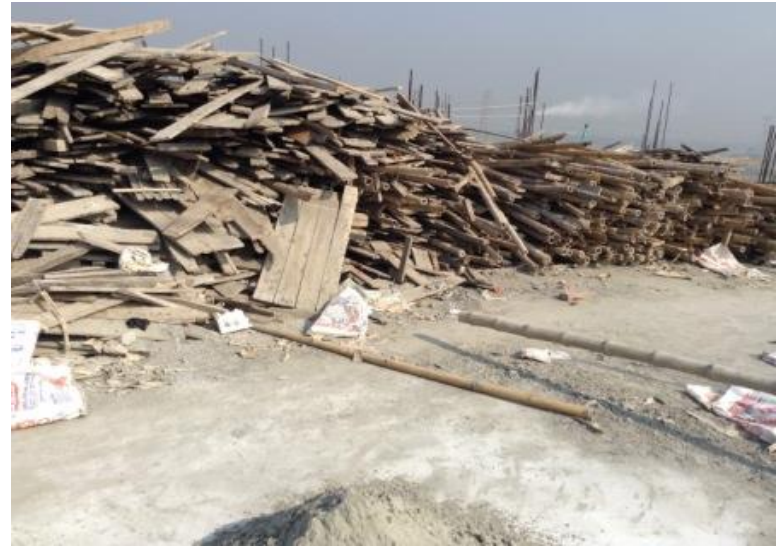
Uncontrolled loading on roof

ITEM 2: Lack of management of floor loading

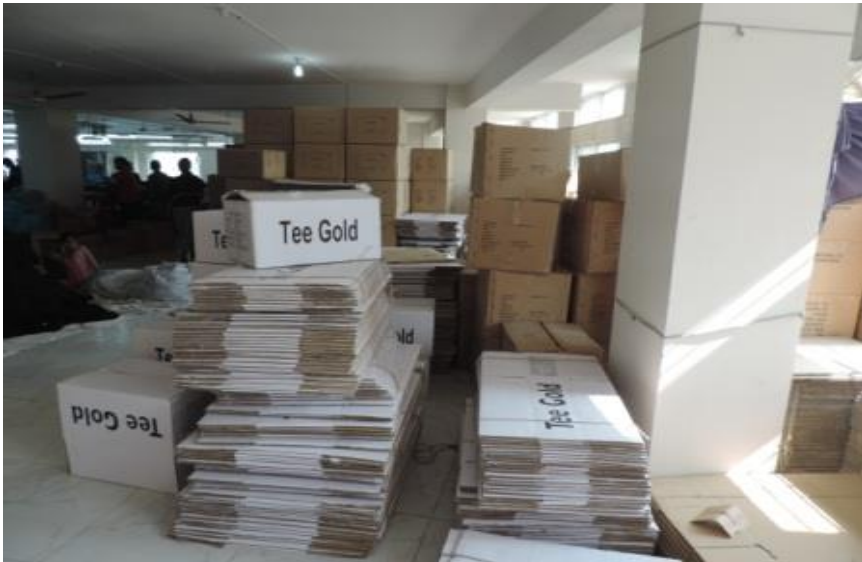
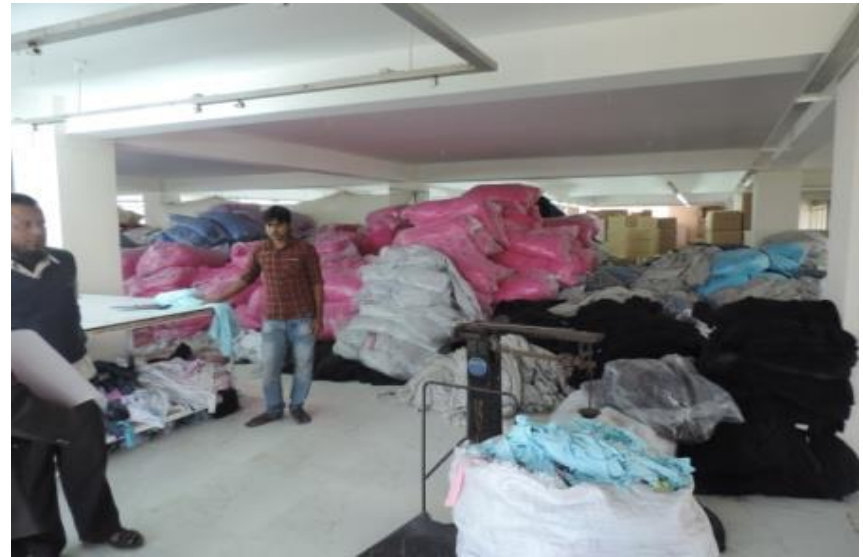
Uncontrolled loading on level 3

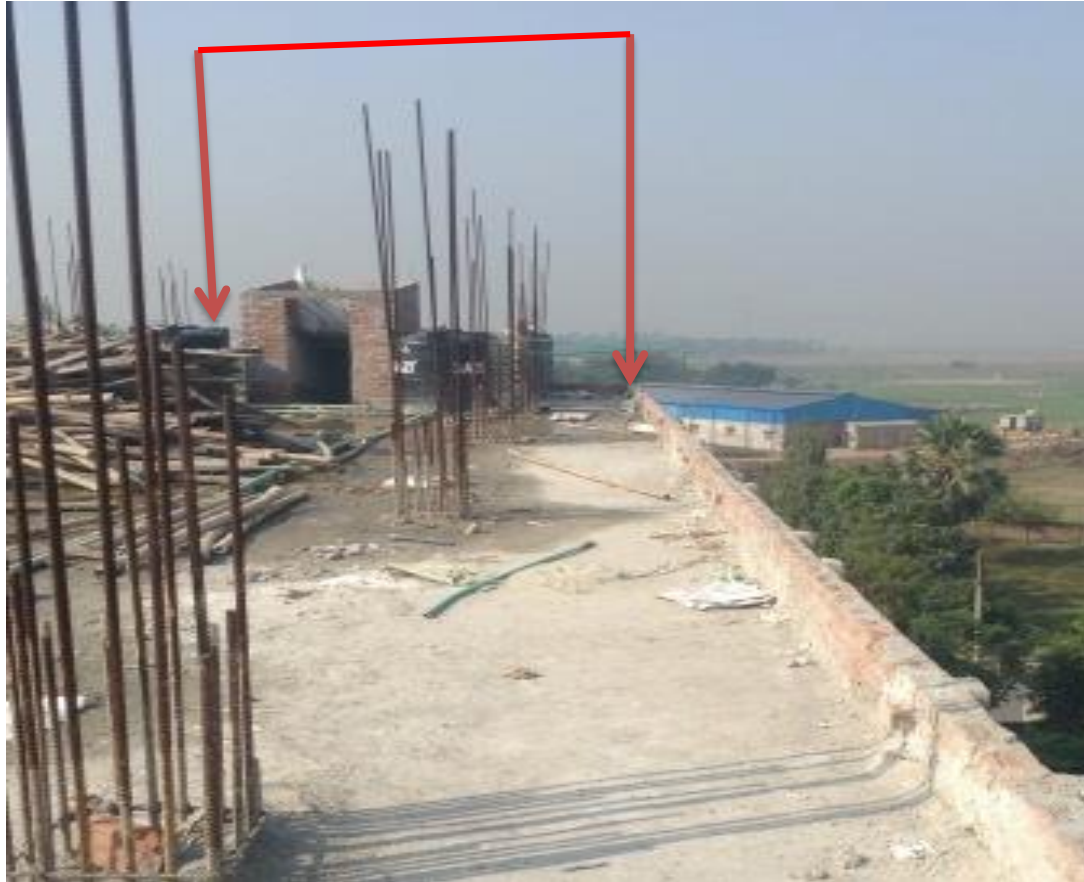
Non-structural issue - Lack of edge protection to roof

No handrail or guarding at the edges of roof slab.
