Man's Attires Ltd. (10792)

Hosiery Ind. Estate, Pl. A-87, Eyanet Nagar, Fatullah, Naranganj

26.05.2014

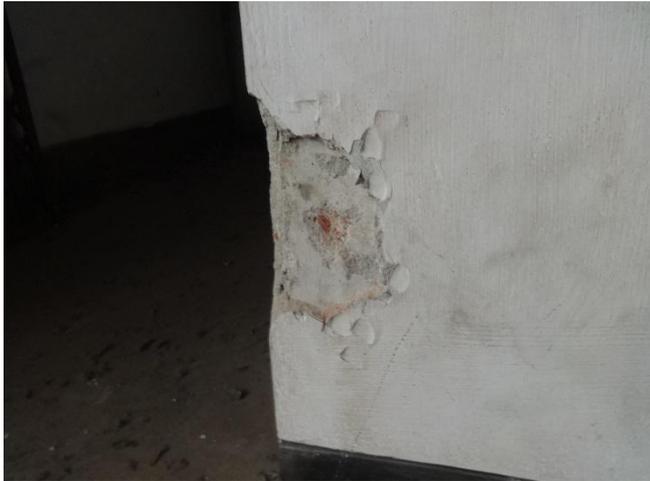
1st Priority 1 Concern: Columns are overstressed

Left; removed plaster on a critical internal column, to establish aggregate type. Below; column schedule, apparently indicating more bars than were present on site, following scans.

Internal columns at the ground floor are indicated as type C3 but only measure 14" x 14" (356mm x 356mm) on site.

Furthermore, our Ferrosan only found 10 bars rather than the 12 indicated on the plans.

Lastly, an additional storey has been added as well as cantilevers at the façades, thus generating more compressive load.

These factors add up to an 'Amber' rating for the columns, requiring load management and further investigation.

Item No.	Observation	Recommended Action Plan	Recommended Timeline
1	Concrete columns are found to be overstressed due to additional loading above the original 6th storey roof and due to discrepancies in the column construction.	Limit loading, see Item 2. Verify insitu concrete stress by 100mm dia. Cores. A Detailed Engineering Assessment of factory to be commenced, see attached scope.	Immediate – Now
2	Concrete columns are found to be overstressed due to additional loading above the original 6th storey roof and due to discrepancies in the column construction.	Produce and actively manage a loading plan for all floor plates within the factory, giving consideration to floor and column capacity. Detailed Engineering Assessment to be completed.	6-weeks
3	Concrete columns are found to be overstressed due to additional loading above the original 6th storey roof and due to discrepancies in the column construction.	Continue to implement load plan. Implement any strengthening recommended by the DEA.	6-months

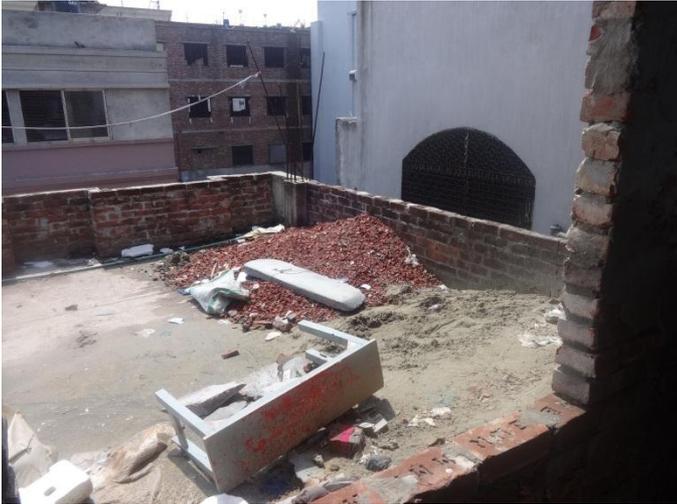
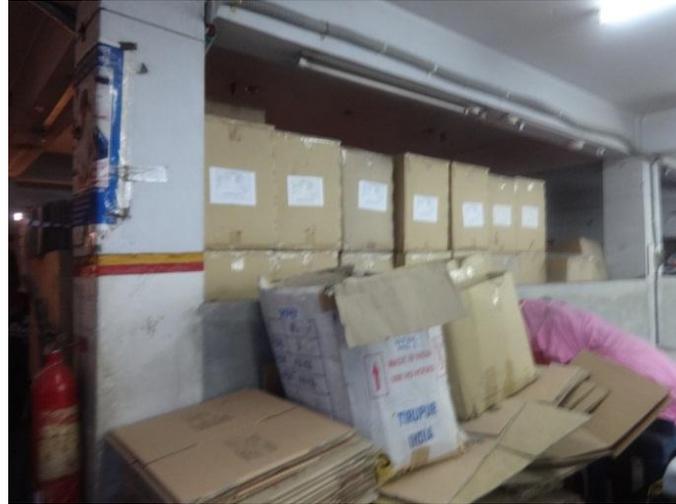
2nd Priority 1 Concern: Presence of heavy loads

At several locations throughout the building, large superimposed loads due to storage, material wastage, or heavy partitions are noted. These loads should be evacuated down to 2.0 kPa. Furthermore, unless the DEA confirms the capacity of the structure, heavy partitions should be removed and replaced by lightweight construction.

4	Fairly heavy loading is noted at several locations, which is a concern in light of the column overstress.	Limit all loading to the current levels. Evacuate all storage down to the ground floor.	Immediate – Now
5	Fairly heavy loading is noted at several locations, which is a concern in light of the column overstress.	Unless otherwise permitted by the DEA (Item 1) remove all masonry partitions and walls from the partial seventh storey and replace with BNBC compliant lightweight construction.	6-weeks
6	Fairly heavy loading is noted at several locations, which is a concern in light of the column overstress.	Continue to implement load plan.	6-months
7	Extensive cracking of beams at 5th and 6th floors.	See Item 2 regarding loading. Inform factory supervisory personnel of the importance of these cracks and implement weekly visual monitoring.	Immediate – Now
8	Extensive cracking of beams at 5th and 6th floors.	Include these floor structures in the DEA. Implement any corrective measures found to be necessary.	6-weeks

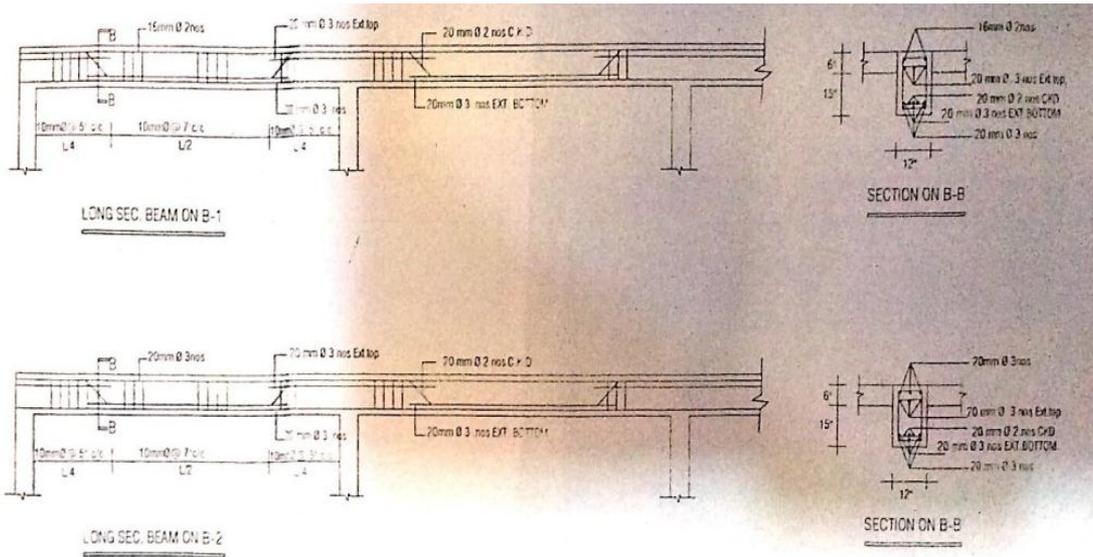
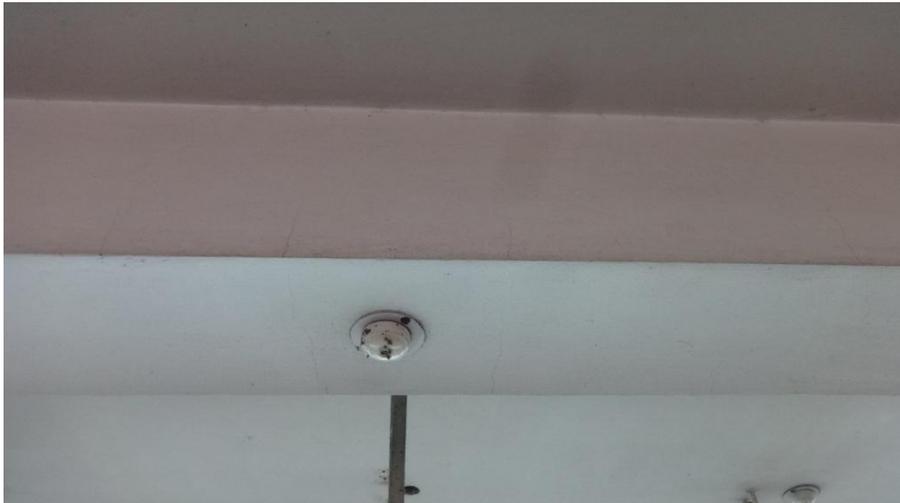
1st Priority 2 Concern: Extensive cracking of floor beams

Visual inspection of the last two storeys uncovered significantly more cracking in floor beams and slab than what is usually observed in buildings of this type.

Several cracks were sounded and chipped-out to reveal crack widths which are not necessarily indicative of structural distress, but this nonetheless remains a concern. Measurements revealed that the depth of the down-stand beams at the last two storeys is less than at the lower storeys (lower storeys are as per plan extract shown), and Ferrosan showed less reinforcing than what is indicated on the drawings.

These cracks must be carefully monitored, and the load on the last two storeys and the roof must be limited unless a complete Detailed Engineering Assessment validates the load capacity of these beams.

9	Extensive cracking of beams at 5th and 6th floors.	Continue to implement load plan.	6-months

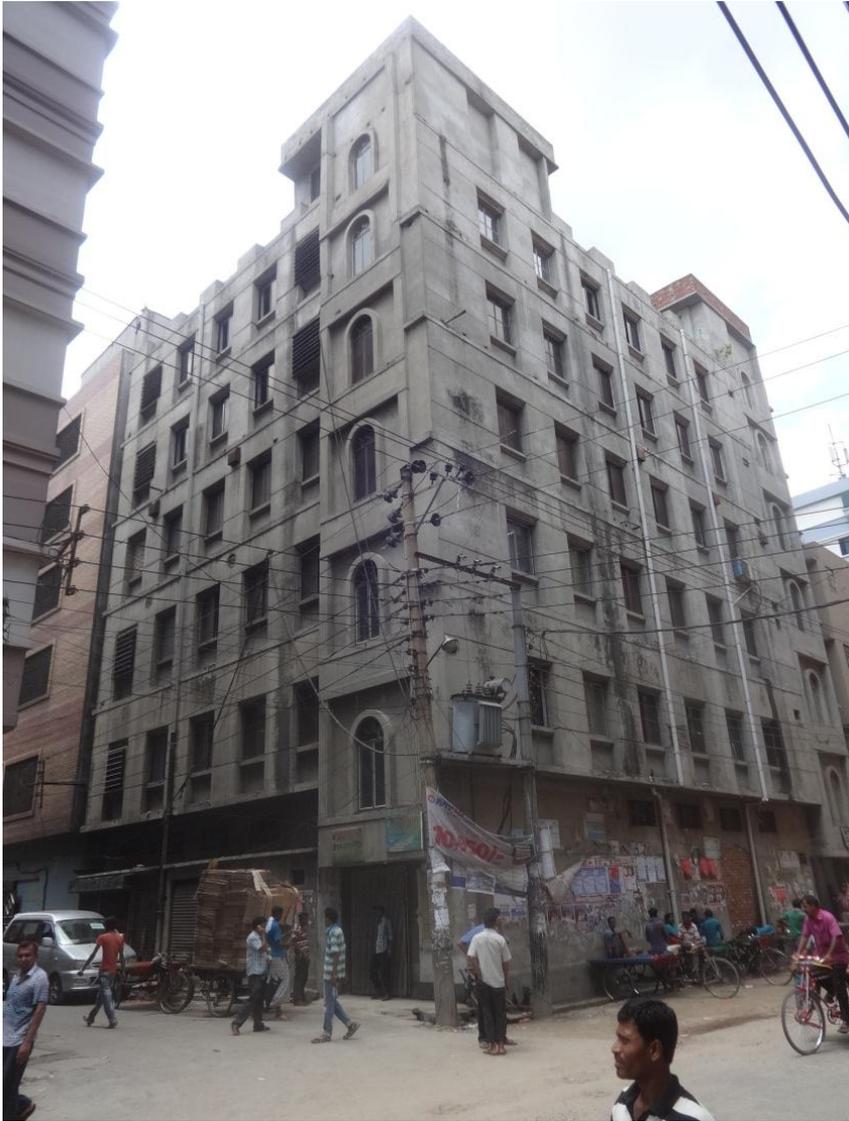
Overall Stability System

The building is entirely concrete-framed, with a beam-and-column construction providing moment frame action. However the extra height of the ground floor is a concern as is the discrepancy in column size with the original drawings.

We require that the lateral stability of the building be investigated in a Detailed Engineering Assessment

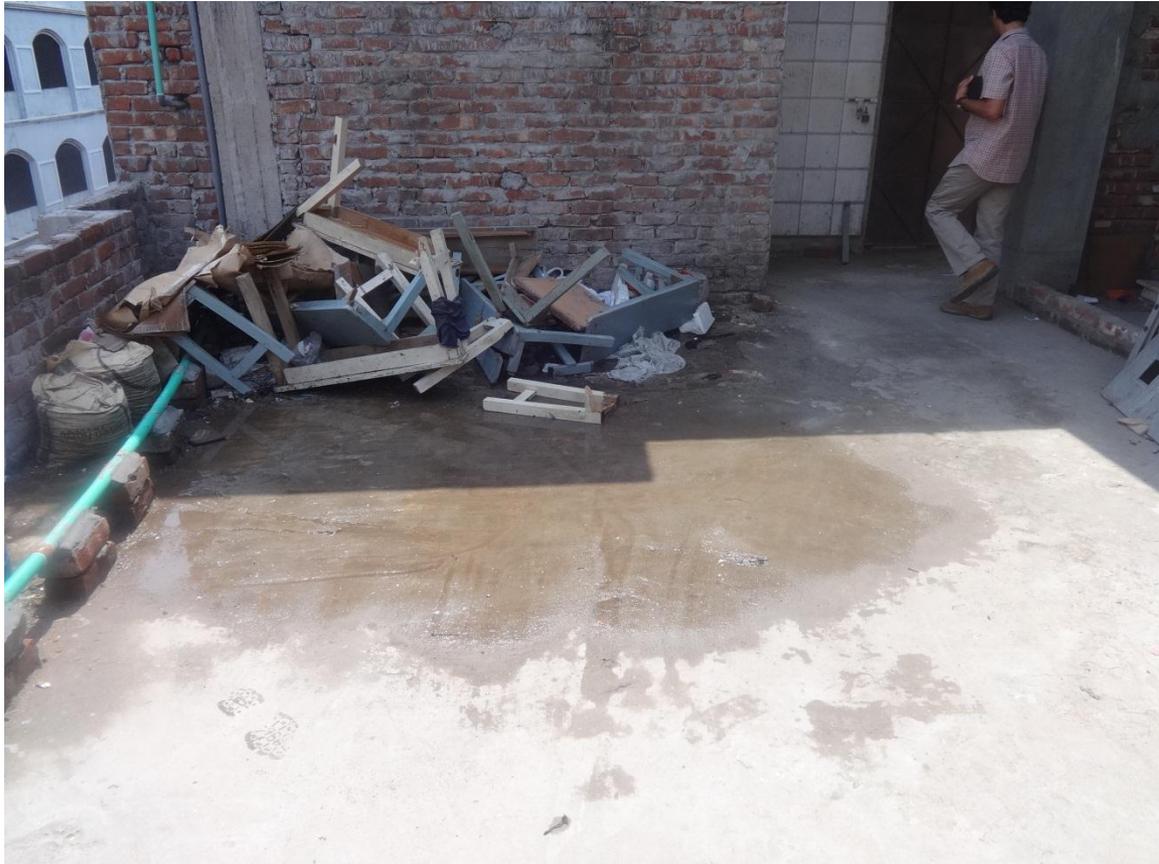
Water Ingress at Roof Level

No waterproofing system was present at roof level. Although no signs of water ingress were observed, the building owner may wish to apply a waterproofing membrane to prevent future issues of water ingress and related structural degradation.
