Mantrust Sweater Ltd

Vogra, Chandana, Gazipur

20 May 2014

Observations

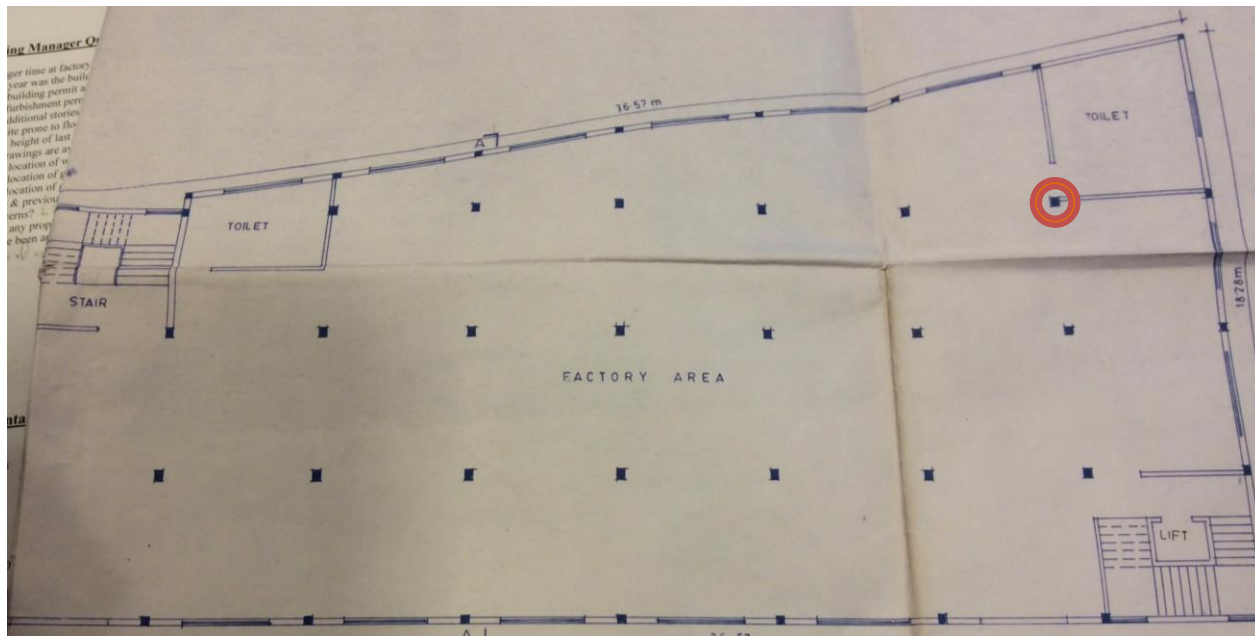
Typical column layout

Small column sizes leading to high column stresses

Due to the small column sizes and the high number of storeys the column stresses are generally high for all columns.

Detail Engineering Assessment and immediate load reductions required.

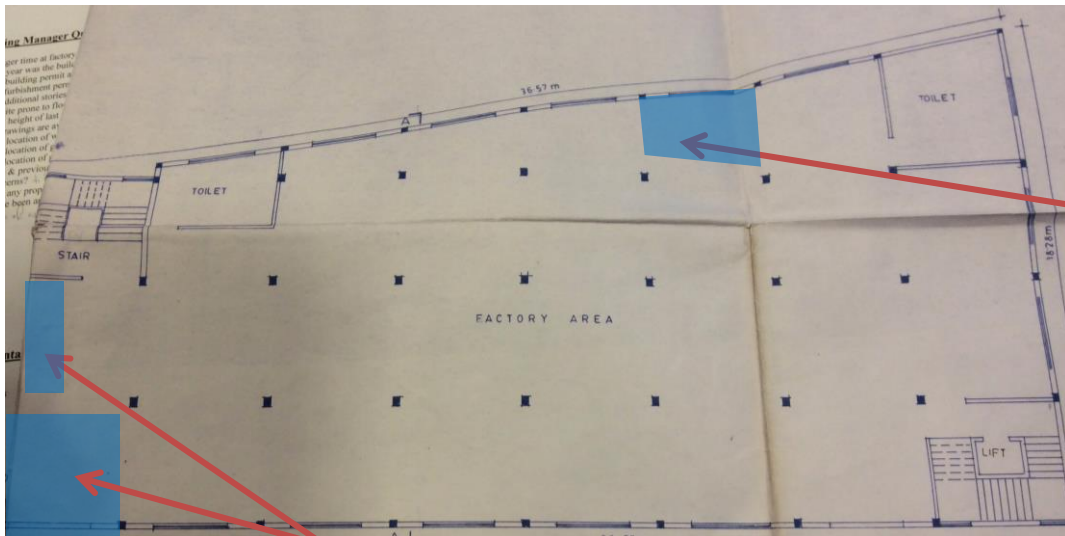
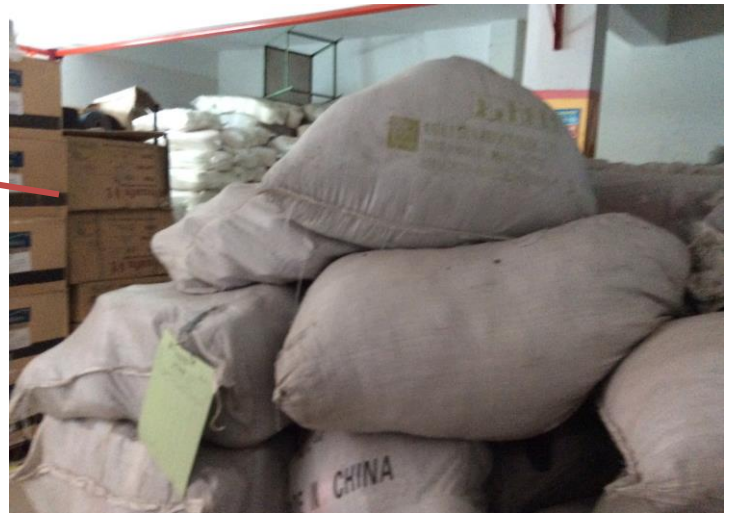
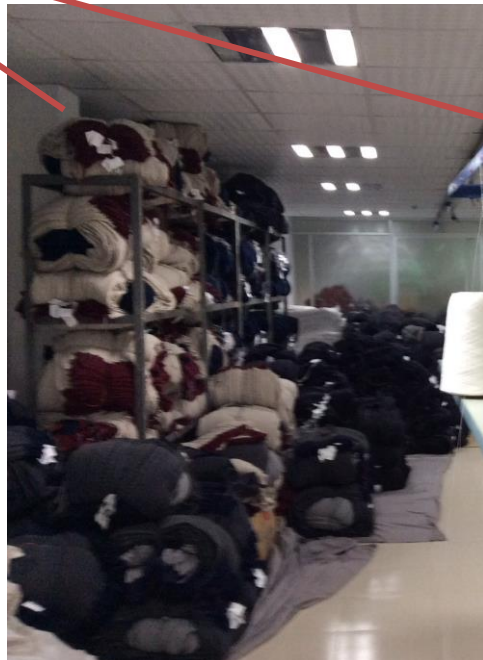
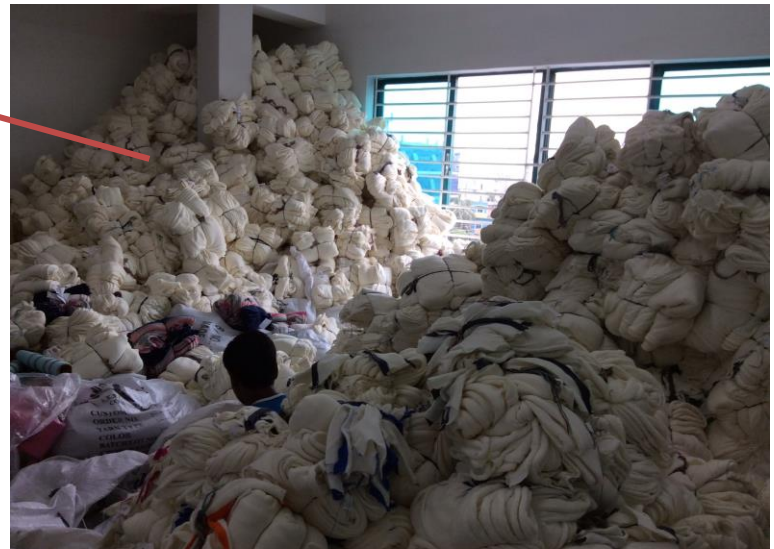
High storage loads in some areas

High storage loads

Building Engineer to create controlled loading plans for all floors which will designate where storage can be placed.

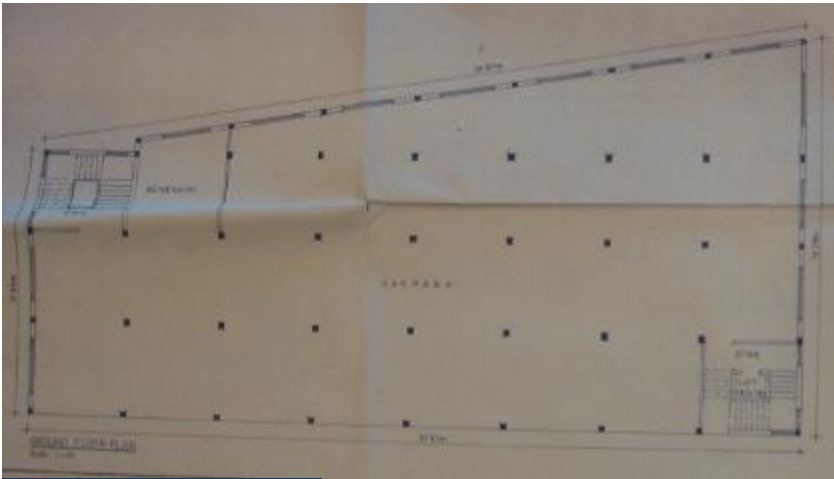
Permit drawing

The building permit for commercial use was given by LGED only in July 2011 when the building was already completed up to the 5th floor. It is unclear what the written restriction on the permit drawing “only layout plan approved” means.

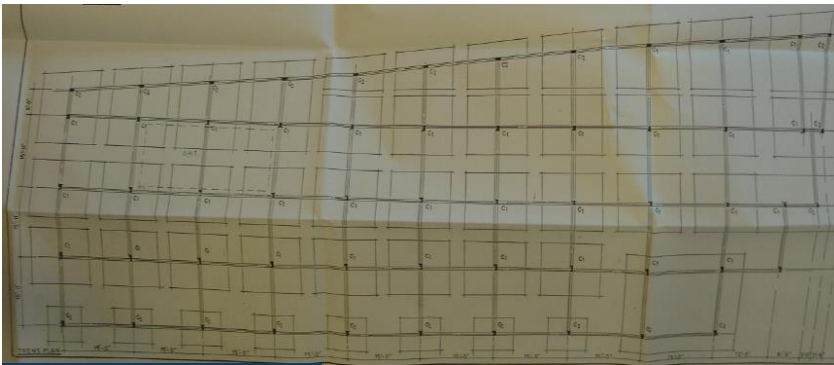
Structural drawing

The structural drawings are from May 2014 when the whole building was already built. They are inconsistent with the permit drawing with regards to the building geometry in several areas.
