FIRE SAFETY INSPECTION REPORT

FASHION EXPOSURE

ELIAS TOWER, 4 HARUNABAD, PALLABI, MIRPUR-12

April 19, 2014

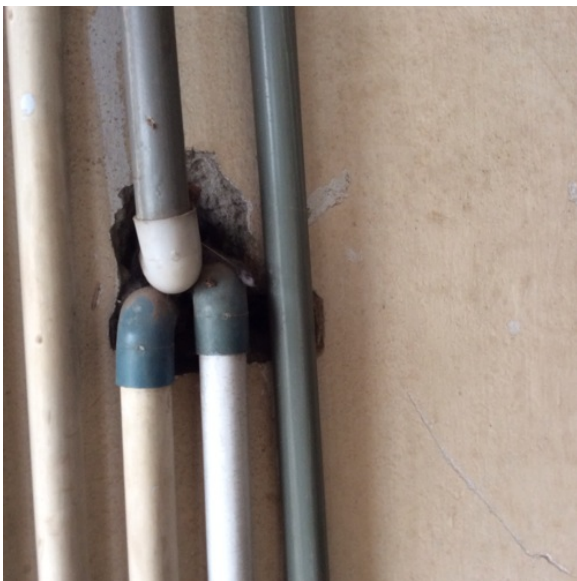
F-3	Fire Rated Construction	Unsealed penetrations and openings are located in West exit stair enclosures.	Seal all penetrations and openings in exit stair enclosure walls to maintain the fire separation.	Within 3 months
-----	-------------------------	---	---	-----------------

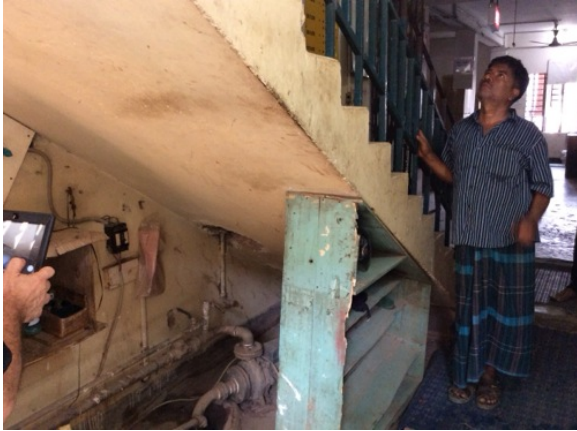
F-4	Egress	Storage was located in the main stair at the ground floor.	Remove all storage from exit stairs and egress paths.	Immediate
-----	--------	--	---	-----------

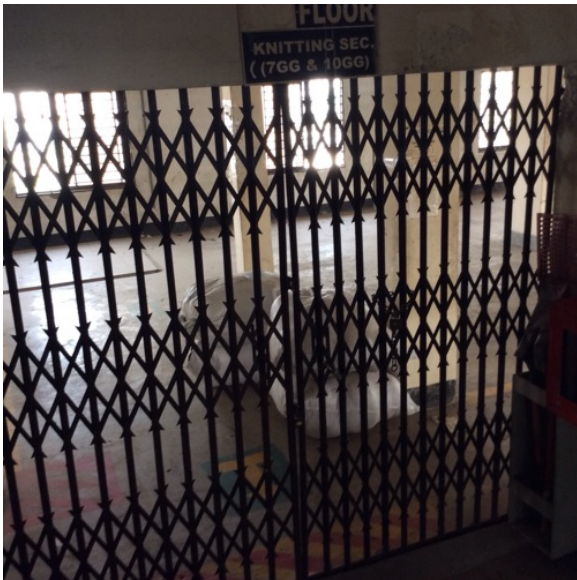
F-6	Egress	Sliding doors are provided throughout main stairwell.	Replace all gates and sliding doors along the means of egress with side-hinged, swinging egress doors. If locks are required for security reasons, utilize special door locking features complying with NFPA 101.	Within 1 month
-----	--------	---	--	----------------

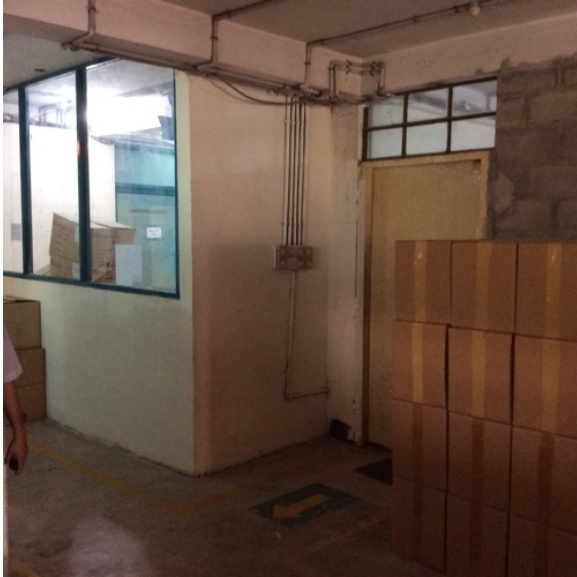
F-7	Egress	The egress path on Floor 2 was through a storage room.	Provide 2-hr fire-rated exit passageway through storeroom, or reconfigure exit discharge path to not pass through storeroom.	Within 3 months
-----	--------	--	--	-----------------

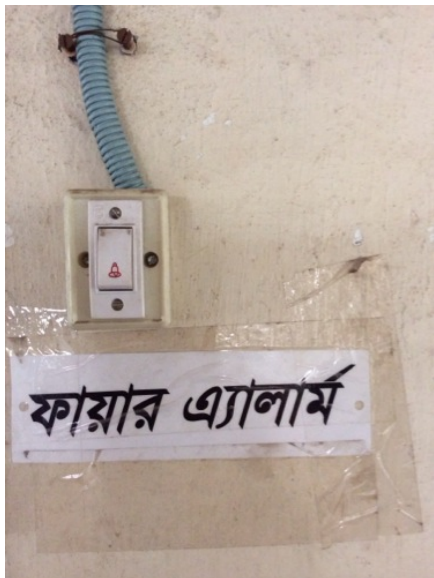
F-8	Fire Protection	The fire alarm system is antiquated, not a listed system, and does not provide alarm and notification features consistent with acceptable standards.	Replace the fire alarm system with a new, listed addressable fire alarm system in accordance with NFPA 72.	Design within 4 months, install within 9 months
-----	-----------------	--	--	---

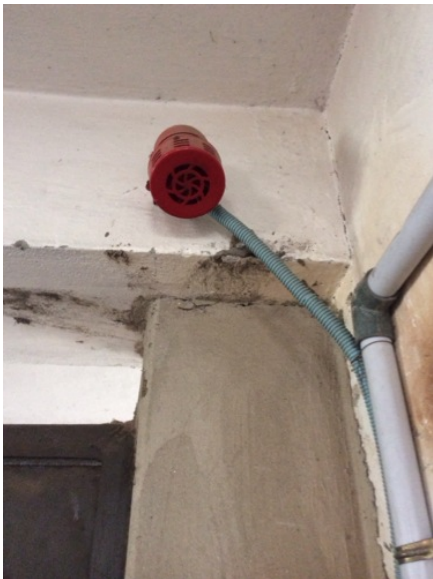
F-9	Fire Protection	The high-rise building has an occupied floor greater than 23m (75 ft) and is not provided with automatic sprinkler protection. The large occupant loads, heavy fuel loading, and anticipated extended egress times warrant sprinkler protection.	Provide automatic sprinkler protection throughout the building in accordance with NFPA 13.	Design within 6 months, install within 12 months
F-10	Fire Protection	Inspection, testing, and maintenance for the fire alarm system it was not in accordance with NFPA 72.	Inspect, test and maintain the fire alarm system, and keep written records on-site, in accordance with NFPA 72.	Within 3 months

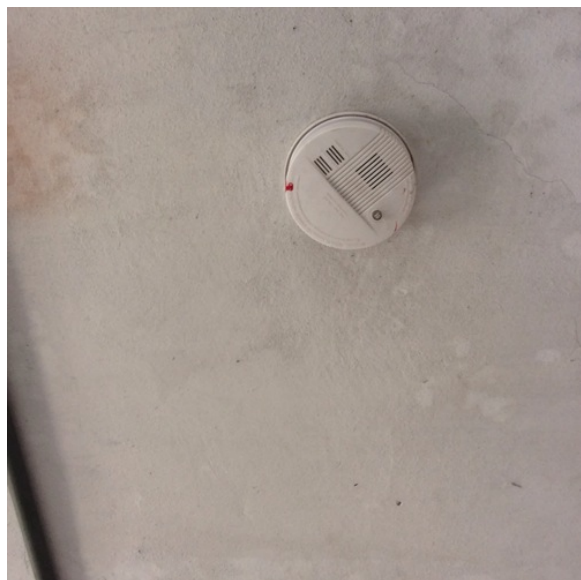
F-11	Fire Protection	The building is equipped with single-station smoke alarms. Smoke alarm activation sounds only a local alarm and does not provide automatic fire alarm notification of occupants.	Remove single-station smoke alarms. Provide automatic smoke detection throughout the building in accordance with NFPA 72.	Within 6 months
------	-----------------	--	---	-----------------
