# **FIRE SAFETY INSPECTION REPORT**

**AMAZON TEX KNIT FASHION LTD**  
**JOBEDA PLAZA, 85 AC DHAR ROAD KALIRBAZAR**

**ACC**   **RD**  
on Fire and Building Safety in Bangladesh

May 21, 2014

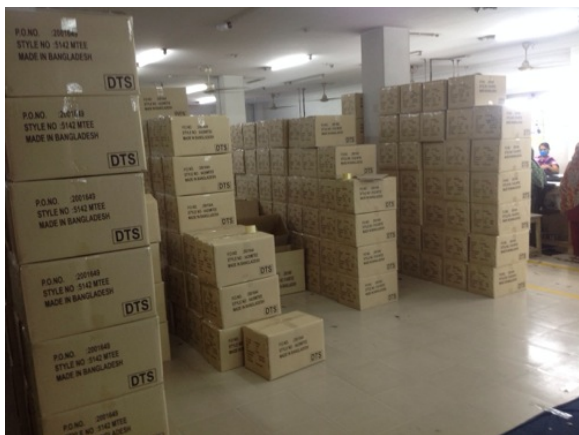
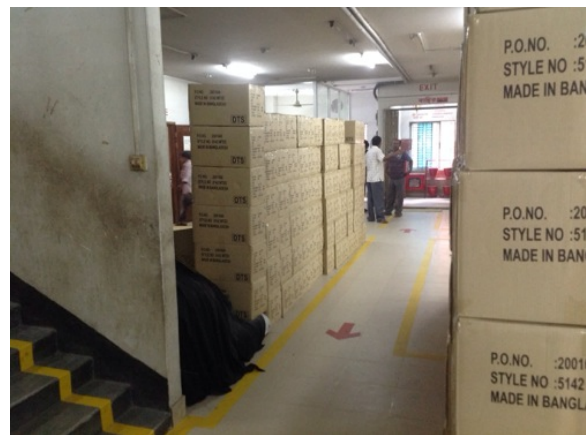
No.	Category	Finding	Recommendation	Remediation Timeframe
F-1	Fire Rated Construction	Areas used for storage on the first floor are not separated by fire-rated construction.	<p>Provide dedicated storage rooms separated by minimum 1-hr fire-rated construction.</p> <p>Where separate storage rooms are not feasible, provide defined storage areas and limit the storage arrangement as follows:</p> <ul style="list-style-type: none"> <li>- Maximum height of 2.4m and maximum area of 23m<sup>2</sup></li> <li>- If sprinkler protected: maximum height of 3.66m and maximum area of 93m<sup>2</sup></li> </ul> <p>Separate areas of unenclosed combustibile storage by a minimum clear distance of 3m.</p>	Within 3 months

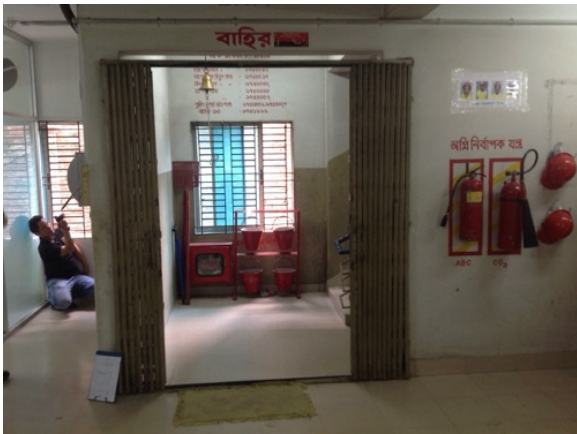
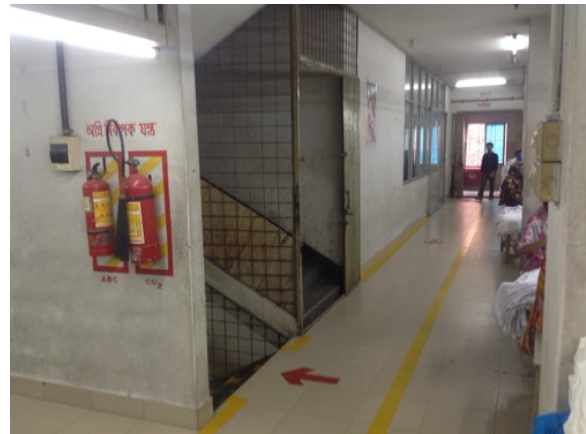
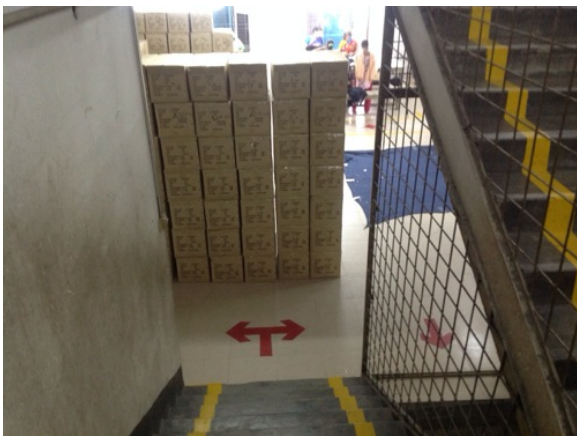
F-2	Fire Rated Construction	The exit stairs are not separated from work areas, other spaces on each floor by fire-rated construction.	Provide minimum 1.5-hr fire rated doors and seal all unprotected openings to separate the exit stairs from work areas and other building spaces on all floor levels. Ensure that the fire doors are self-closing and positive latching and that they are provided with fire exit (panic) hardware where serving production floors.	Within 3 months
-----	-------------------------	---	--	-----------------

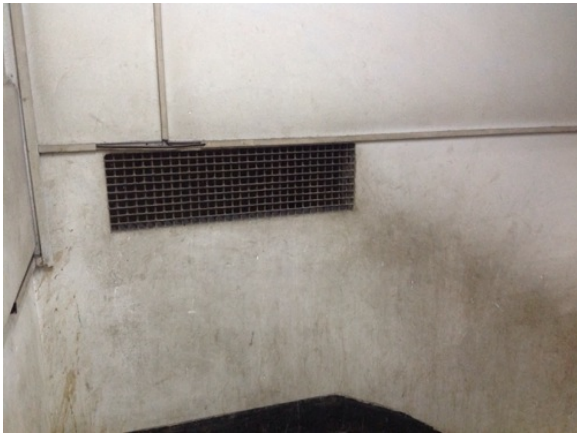
F-3	Fire Rated Construction	Unsealed penetrations and openings are located in exit stair enclosures. The west exit has these opening on all floors.	Seal all penetrations and openings in exit stair enclosure walls to maintain the fire separation.	Within 3 months
-----	-------------------------	---	---	-----------------

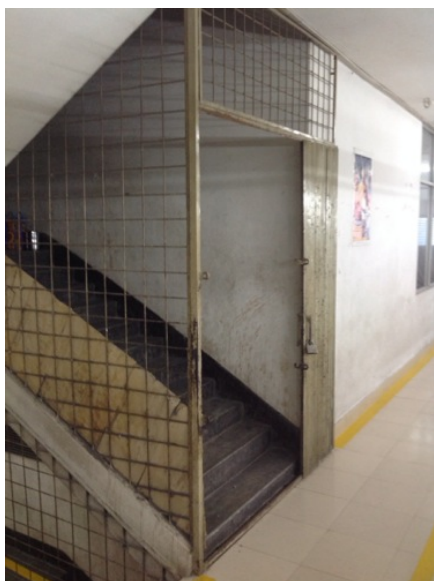
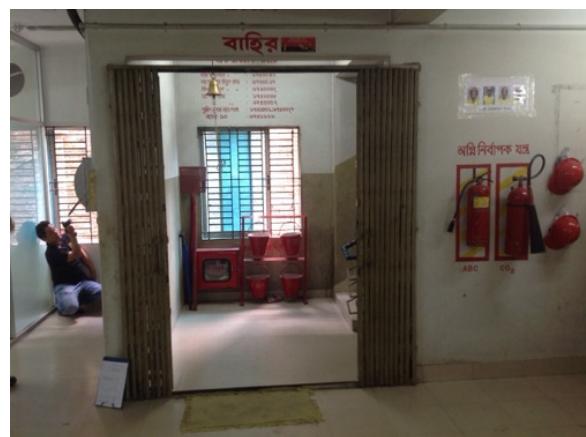
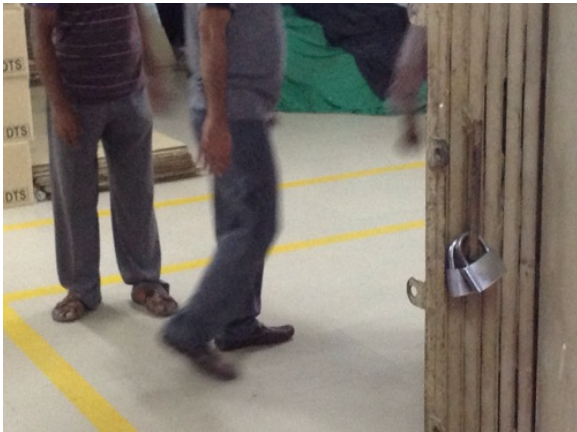
F-5 Egress

Egress doors / gates with locking features are provided at building exits, exit stairs, along egress routes, exit discharge.

These locking features can be found on all exits, on all floors throughout the factory.

Remove locking features from all egress doors / gates.

If locks are required for security reasons, utilize special door locking features complying with NFPA 101.

Immediate

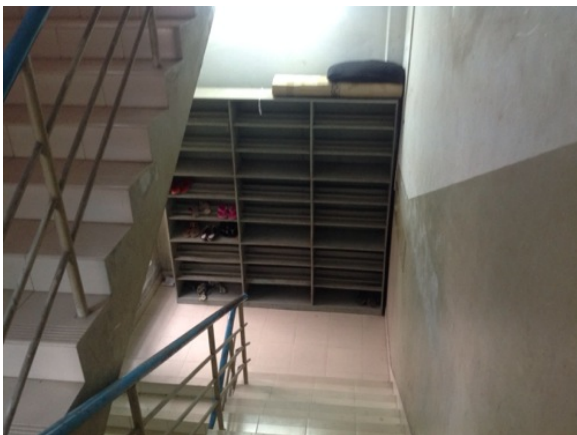
F-6	Egress	Storage was located in the west exit stair.	Remove all storage from exit stairs and egress paths.	Immediate
-----	--------	---	---	-----------

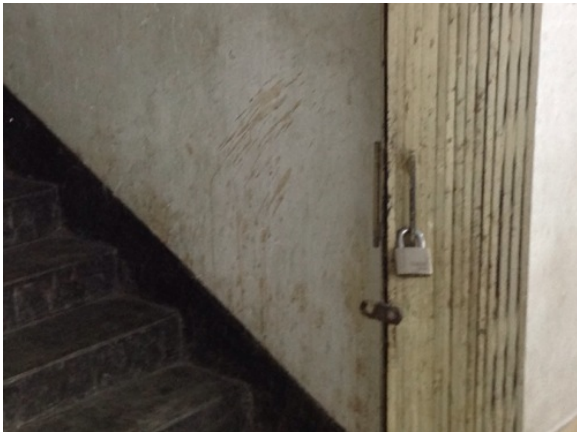
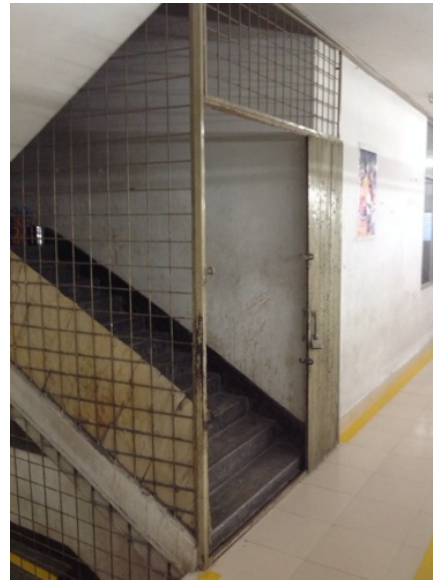
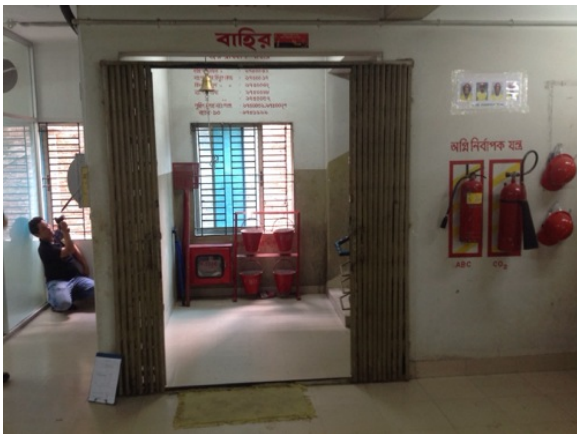
F-7	Egress	Collapsible gates are provided at building exits, exit stairs, along egress routes, exit discharge. These were at exit access on all floors for all four exit stairwells as well as all three exit discharges	Replace all gates / sliding doors along the means of egress with side-hinged, swinging egress doors.  If locks are required for security reasons, utilize special door locking features complying with NFPA 101.	Within 1 month
-----	--------	---	--	----------------

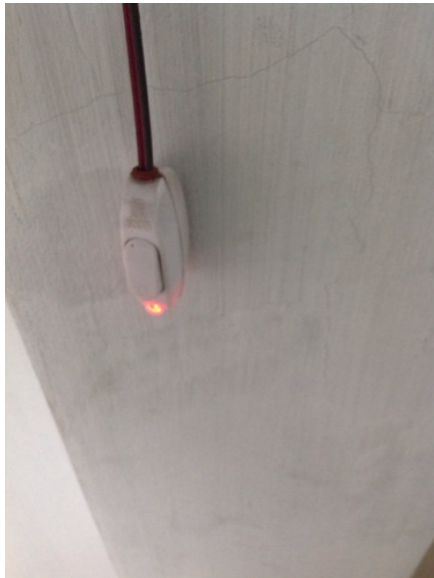
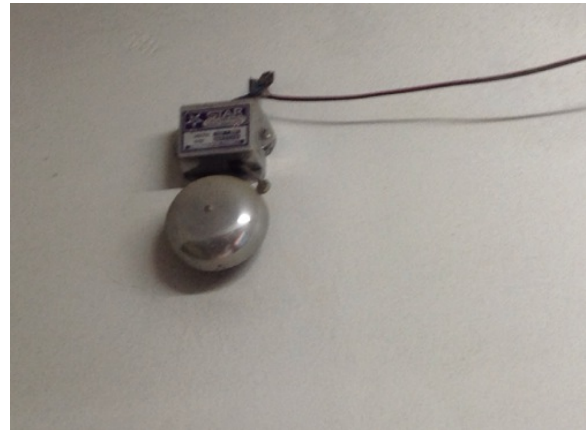
F-8	Fire Protection	The fire alarm system is antiquated, not a listed system, and does not provide alarm and notification features consistent with acceptable standards.	Replace the fire alarm system with a new, listed addressable fire alarm system in accordance with NFPA 72.	Design within 4 months, install within 9 months
-----	-----------------	--	--	---

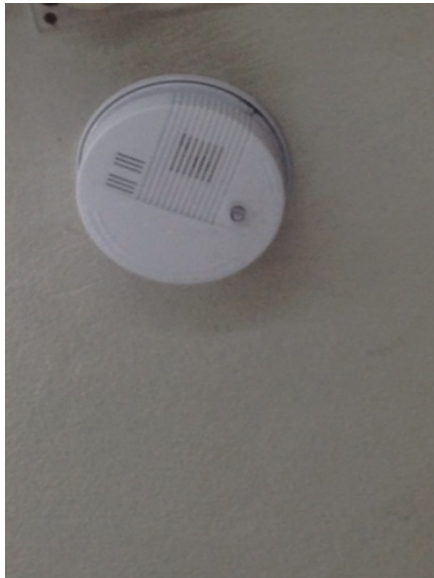
F-9	Fire Protection	Inspection, testing, and maintenance for the fire alarm system was not in accordance with NFPA 72.	Inspect, test and maintain the fire alarm system, and keep written records on-site, in accordance with NFPA 72.	Within 3 months
F-10	Fire Protection	The building is equipped with single-station smoke alarms. Smoke alarm activation sounds only a local alarm and does not provide automatic fire alarm notification of occupants.	Replace the single-station smoke alarms with automatic smoke detectors tied into the fire alarm system. Configure the fire alarm system to initiate occupant notification upon activation of any two smoke detectors in addition to the manual fire alarm stations.	Within 6 months

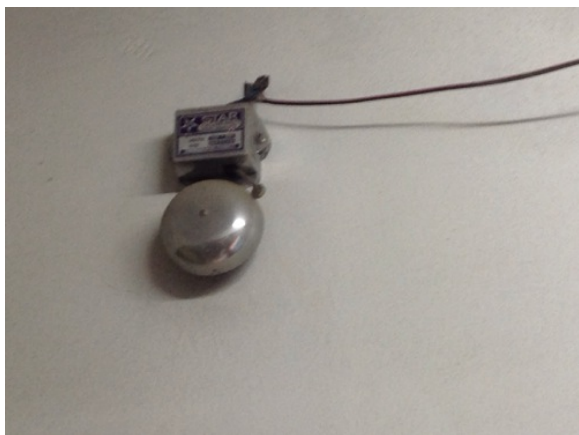
F-11	Fire Protection	The fire alarm system does not appear to provide adequate audible notification coverage. A functional test was preformed. the system is only in the west ext access on the first floor and consist of a single bell.	Provide additional notification appliances such that the fire alarmsystem is audible throughout the building in accordance with NFPA 72.	Within 6 months
------	-----------------	--	--	-----------------

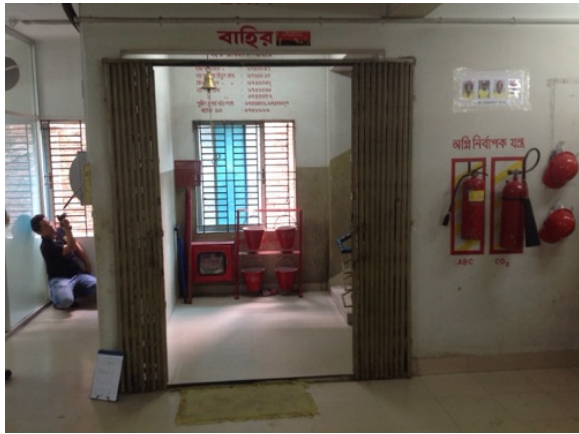
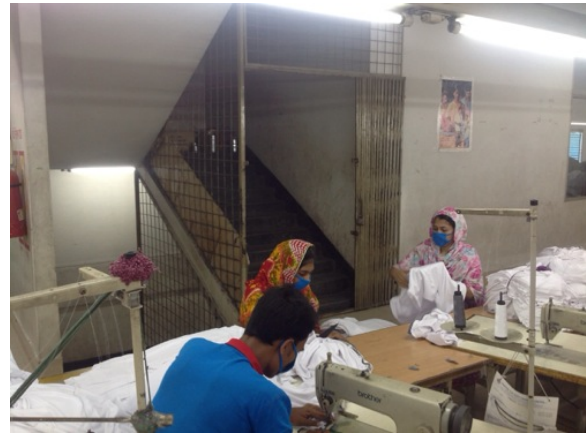
F-12	Egress Lighting	Exit sign not provided at exit for both floors 1 and 2 for both exit stairwells.	Provide exit signs above all exits to the exterior and all doors to the exit stairs.	Within 1 month
------	-----------------	--	--	----------------
