FIRE SAFETY INSPECTION REPORT

TARATEX (BD) LTD.
PLOT-30, SATAISH ROAD, GAZIPUR, TONGI
OTHER FACTORIES: S.P.M DESIGN LTD.

ACC   **RD**
on Fire and Building Safety in Bangladesh

April 26, 2014

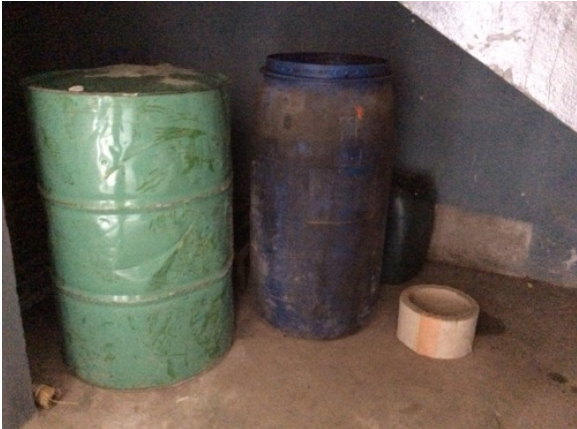
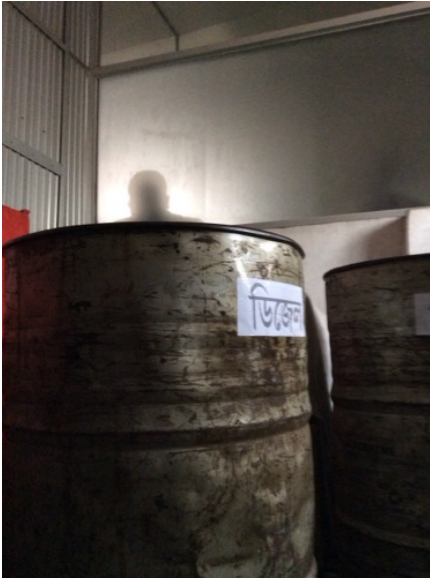
No.	Category	Finding	Recommendation	Remediation Timeframe
F-1	Fire Rated Construction	Flammable liquid storage was located at the base of both the exit stairwells.	Remove the hazardous materials / flammable liquid storage from the stair enclosures and ensure that it is sperated by a minimum 2-hr fire-rated construction. Seal and/or protected all openings to maintain the required fire separations.	Immediate
<div style="display: flex; justify-content: space-around;">

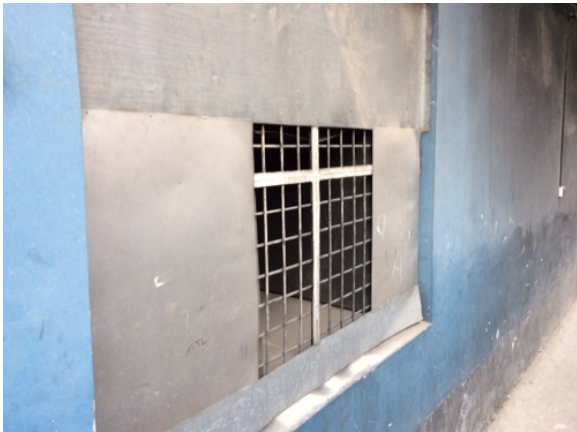
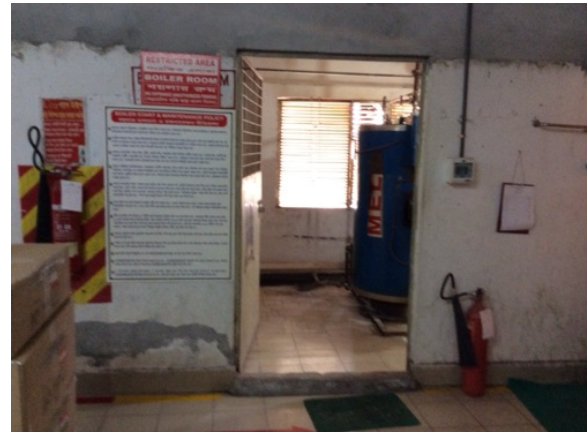
</div>				
F-2	Fire Rated Construction	The generator and transformer room on the ground floor and the boiler room on the 1st floor were not separated from the adjacent working areas by means of fire rated construction (non-rated doors).	Separate the generator, transformer and boiler room from working areas by a minimum 2-hr fire-rated construction. Seal and/or protected all openings to maintain the required fire separations.	Within 3 months

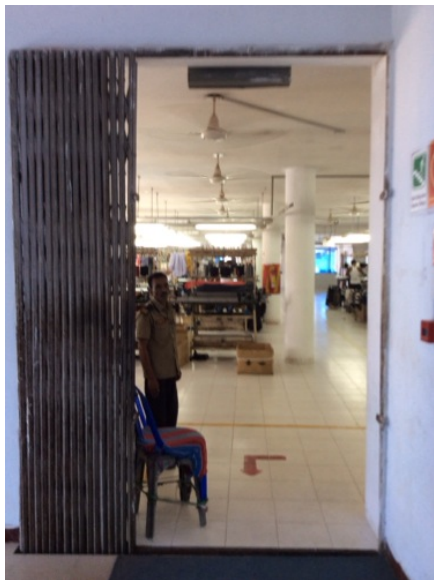
F-4	Fire Rated Construction	The exit stairs are not separated from work areas on each floor by fire-rated construction.	Provide minimum 1.5-hr fire rated doors and seal all unprotected openings to separate the exit stairs from work areas and other building spaces on all floor levels. Ensure that the fire doors are self-closing and positive latching and that they are provided with fire exit (panic) hardware where serving production floors. If fire doors are required to be held open for functional reasons, provide automatic-closing devices tied to the fire alarm system.	Within 3 months
-----	-------------------------	---	---	-----------------

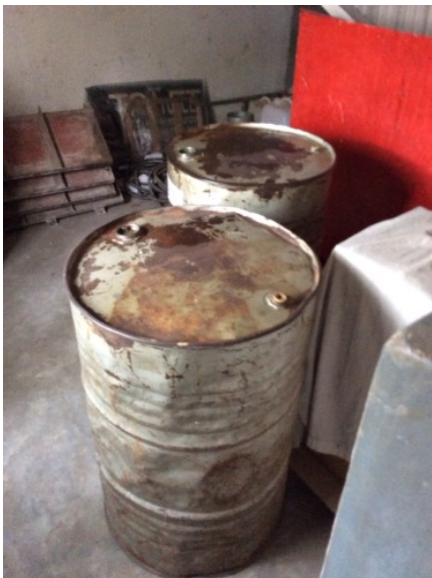
F-8 Egress

Combustible storage was located at the base of both the exit stair enclosures.

Remove all storage from exit stairs and egress paths.

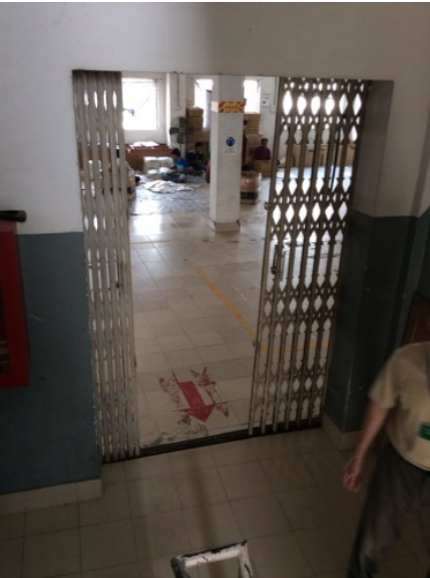
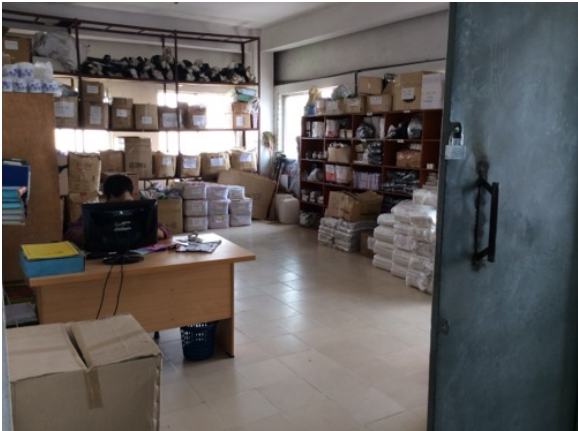
F-9	Egress	Collapsible gates and sliding doors are provided at all building exits, exit stairs and exit discharges.	Replace all gates / sliding doors along the means of egress with side-hinged, swinging egress doors.	Within 1 month
			If locks are required for security reasons, utilize special door locking features complying with NFPA 101.

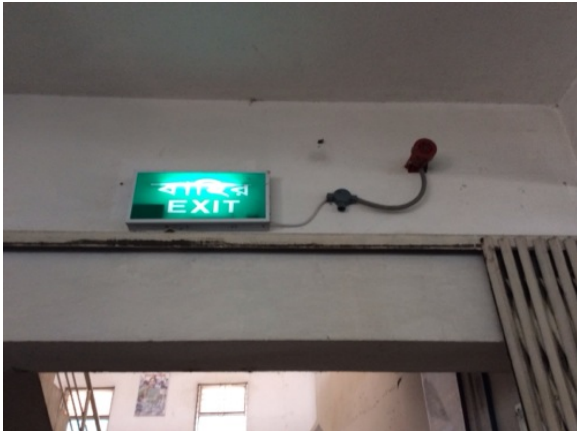
F-12	Fire Protection	The fire alarm system is antiquated, not a listed system, and does not provide alarm and notification features consistent with acceptable standards.	Replace the fire alarm system with a new, listed addressable fire alarm system in accordance with NFPA 72.	Design within 4 months, install within 9 months
------	-----------------	--	--	---

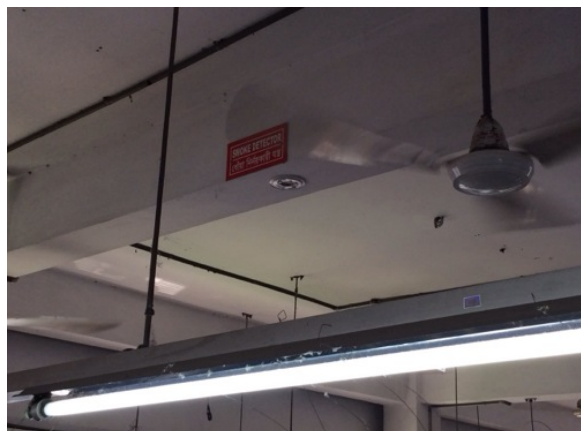
F-13	Fire Protection	The building is equipped with single-station smoke alarms. Smoke alarm activation sounds only a local alarm and does not provide automatic fire alarm notification of occupants.	Remove single-station smoke alarms. Provide automatic smoke detection through out the building in accordance with NFPA-72.	Within 1 months
------	-----------------	--	--	-----------------
